Preliminary Arborist Report

**11 El Camino Real
San Carlos, CA**

December 2022
Revised March 2023

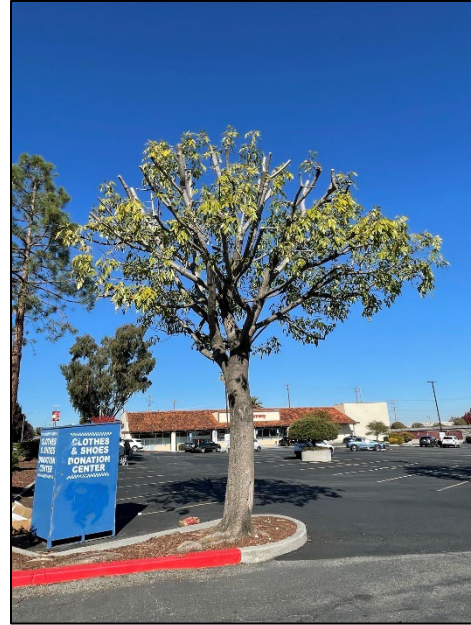
Evergreen ashes #135 and 137 were in fair condition, and #134 was in good condition. Ash #135 and 137 had been recently topped (Photo 1). Ash #134 was in good condition with vigorous foliage. Trunk diameters ranged from 8 to 19 inches with an average of 14 inches.

Photo 1. Ash #137 had been recently topped and was growing in landscape bulb-out.

137	Evergreen ash	16	Yes	3	Low	Remove	Large surface roots; trunk wound east; multiple attachments at 8'; recently topped.
138	Canary Island pine	20	Yes	3	Low	Remove	Low live crown ratio; good upright structure; surface roots; healthy crown.
139	Canary Island pine	16	Yes	3	Low	Remove	Low live crown ratio; good upright structure; suppressed east; surface roots; thin canopy.
140	Southern live oak	8	No	4	Moderate	Remove	In raised planter; can't see root flare; multiple attachments at 4'; full healthy crown.
141	Southern live oak	6	No	3	Moderate	Remove	In raised planter; can't see root flare; multiple attachments at 5'; small twig dieback; slightly thin crown.
142	Evergreen pear	8	No	4	Moderate	Remove	Multiple attachments at 5'; small twig dieback; healthy crown.
143	Chinese pistache	11	Yes	4	Moderate	Remove	Codominant trunks arise from 1'; narrow union; small twig dieback; healthy canopy.
144	River red gum	45	No	3	Low	Remove	Multiple large attachments at 7'; history of large branch failure; topped; weakly attached epicormic growth; small twig and branch dieback.
