Appendix A: Existing Conditions Hydraulics and Hydrology Memorandum

TO:	Grace Le, PE	FROM:	Andrew Smith, PE Angela Hogan, PE Chris Feng, PE
CC:	Camille Bandy, PE, QSD Freyer and Laureta	Jeff Tarantino, PE Freyer and Laureta	
DATE:	December 19, 2024		
SUBJECT:	Pulgas Creek Watershed Study: Existing Conditions Hydraulics and Hydrology Memorandum Rev. 1

Pulgas Watershed Study
Existing Conditions H&H Memo
City of San Carlos, San Mateo, CA

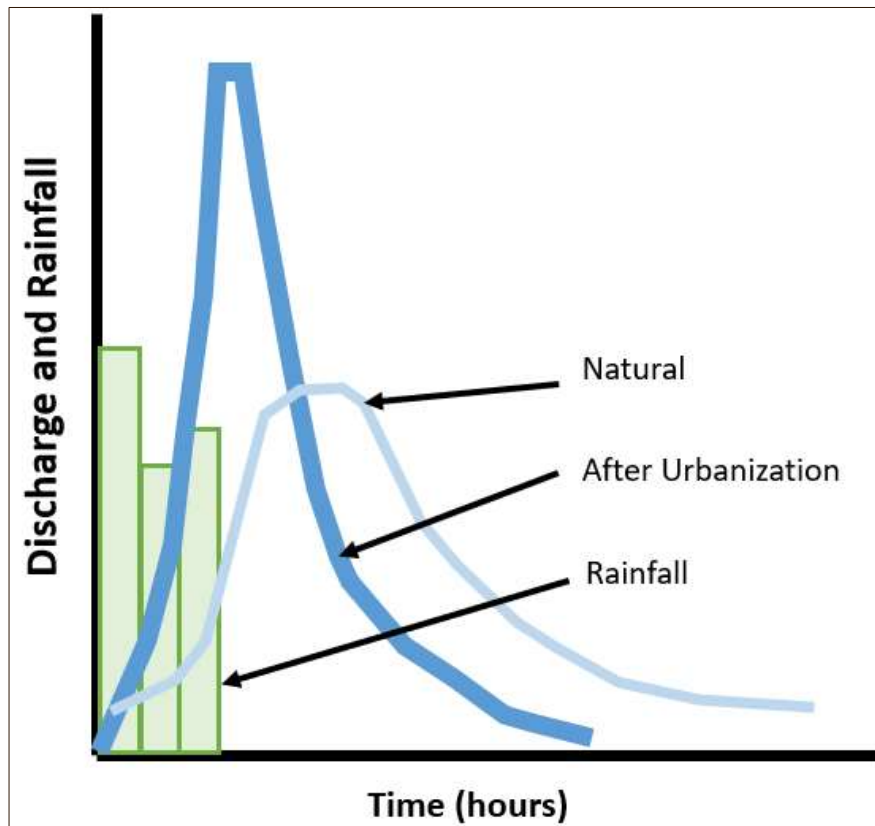
Exhibit 1. Impact of urbanization of previously undeveloped land on the flow hydrograph.

The City of San Carlos, CA (City) is interested in developing a better understanding of the Pulgas Creek watershed and establishing a management plan with the aim of enabling creek restoration, increasing public access to sections of the creek, addressing existing flooding issues, and developing climate change mitigation strategies. A previous watershed study and hydraulic model was developed by GHD in 2017 as a part of the City's Storm Drain Master Plan (City of San Carlos, 2017). Traditionally, flood risk reduction efforts have focused on increasing channel capacity with large conduits which require substantial funding and have considerable impacts on traffic during implementation. More recently, guidance for managing watersheds also focus on reducing peak flow and sedimentation by re-naturalizing the watershed (Exhibit 1).

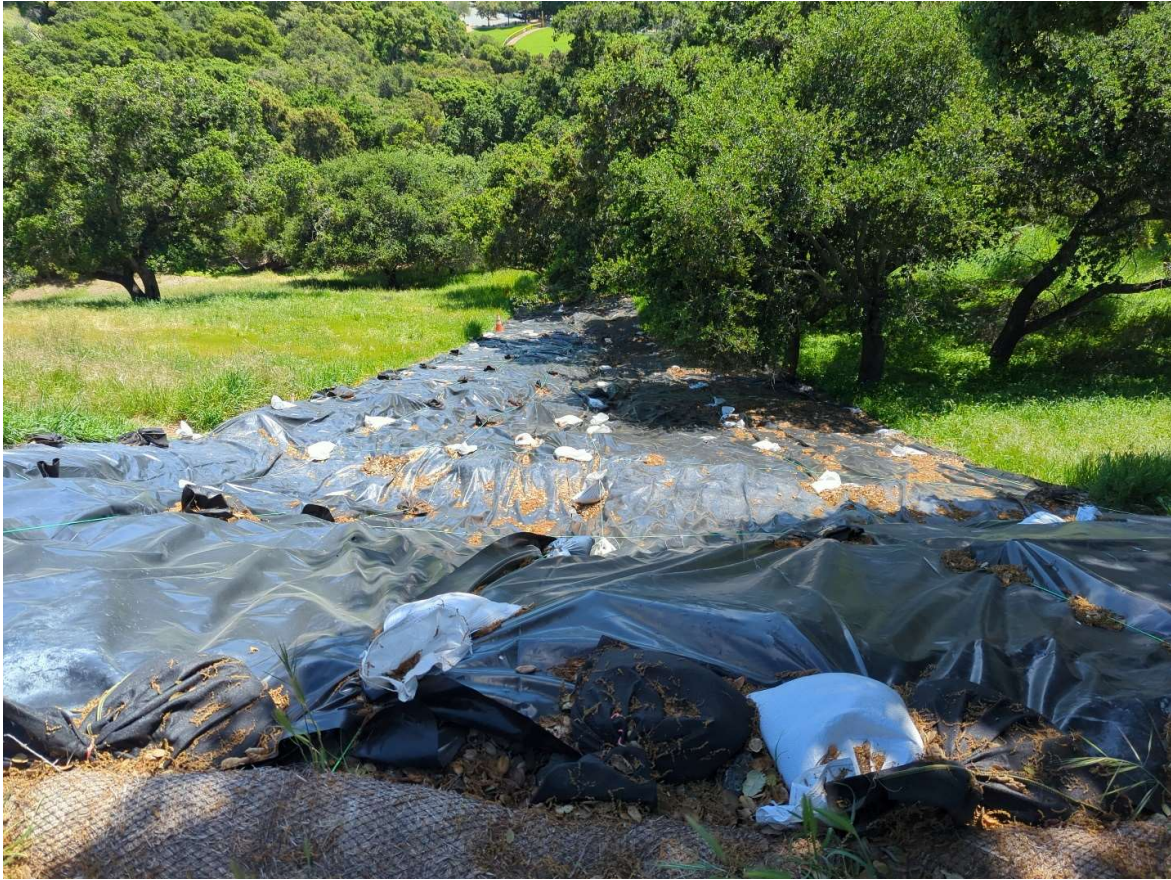
Exhibit 2. Temporarily stabilized landslide from the 2022-2023 storms along Dartmouth Ave above Arguello Park. Photo taken by WRA 4/12/24.

Sedimentation is the result of suspended and bed-load sediment settling out of the water column where low energy conditions exist. Sediment is introduced to the waterway through erosion or landslides and can exist anywhere water flows, such as where precipitation impacts with the ground, on roads, inside storm water infrastructure, and within the creeks. Erosion can occur anywhere throughout the watershed where there is exposed soil experiencing sufficiently high local flow and can increase from small to large volumes of sediment. Sediment sources can include uncovered earth disruption activities, such as construction or landscaping, as well as creek bank erosion. Landslides typically involve large volumes of soil moving either immediately into the waterway if they occur along the creek banks, or over a longer period if they occur on upper hillslopes, farther from the waterway. They typically occur where topography is steep and geological, morphological, and hydrological conditions result in a weak region of the landscape (*Exhibit 2*). The majority of landslides within the City occur in the upper watershed, west of Alameda de las Pulgas (California Department of Conservation - California Geological Survey, 2015).

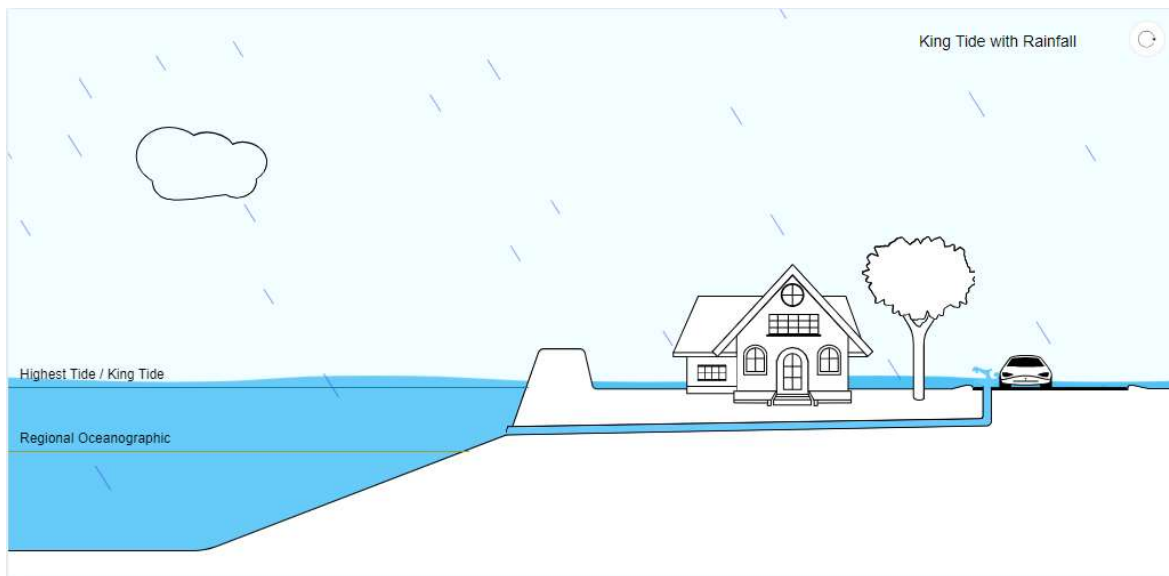
Exhibit 3. Tidal limitations on stormwater drainage and flooding. Graphic by (NOAA, 2024)

Sources of inflow of water to the system includes precipitation runoff and potential groundwater springs, while outflow includes discharge into the San Francisco Bay, infiltration into the soil, evaporation, and transpiration. Groundwater levels during the winter can be as shallow as 3 feet below the ground surface east of El Camino Real, severely limiting infiltration potential and channel conveyance capacity (California Department of Water Resources, 2024). As storm flows reach the lower watershed, water surface elevations (WSEs) are altered by tidal and groundwater elevations, causing storm flows to overtop channel banks and pop out from manholes (*Exhibit 3*). This issue will be exacerbated by climate change through higher intensity storms and rising sea levels.

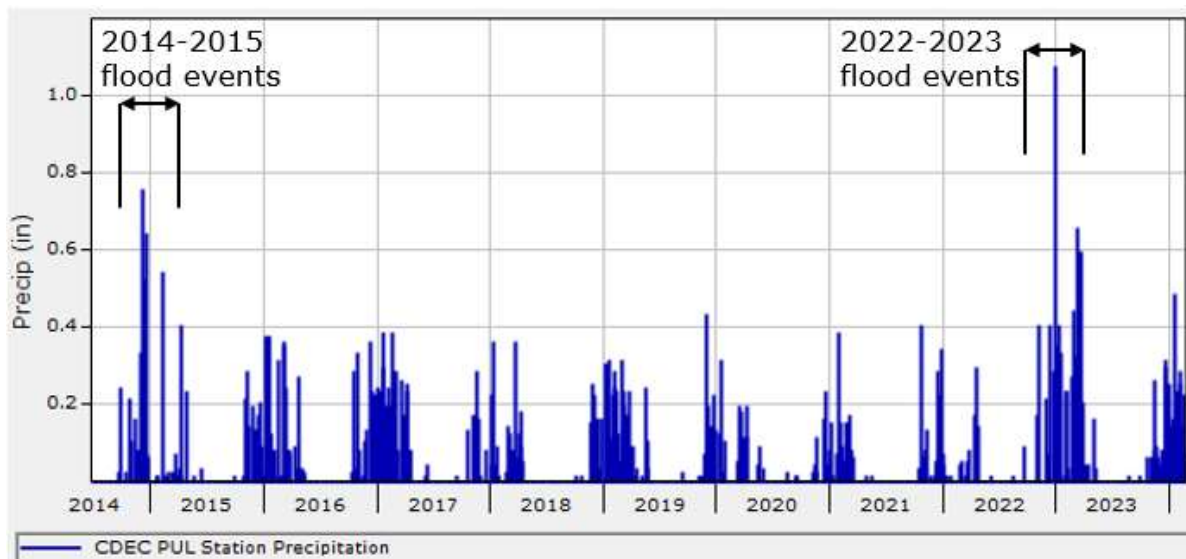
Exhibit 4. Flood impact years compared to hourly precipitation data from the CDEC PUL station

Historically, flooding has occurred in the more heavily urbanized reaches of the Pulgas Creek watershed east of Alameda de las Pulgas, especially along El Camino Real. More recently, flooding effects have been observed in the less urbanized reaches of the watershed west of Alameda de las Pulgas, particularly at properties abutting existing parks and less developed regions. All available flood reports from those provided in the Storm Drain Master Plan and from the 2023 floods are shown in Figure 3. Based on a comparison of flood events to hourly precipitation intensity data from the CDEC station, the Pulgas watershed appears to be at risk of flooding beginning with rainfall intensity of 0.75 inch over one hour (*Exhibit 4*), equivalent to a 10-year precipitation event based on the National Oceanic and Atmospheric Administration's (NOAA) Atlas 14 (*Exhibit 5*). Flood timing data is based on the recorded time of reporting and not necessarily the exact time the flood occurred, limiting this analysis from assessing hour-scale precipitation to flooding relations.

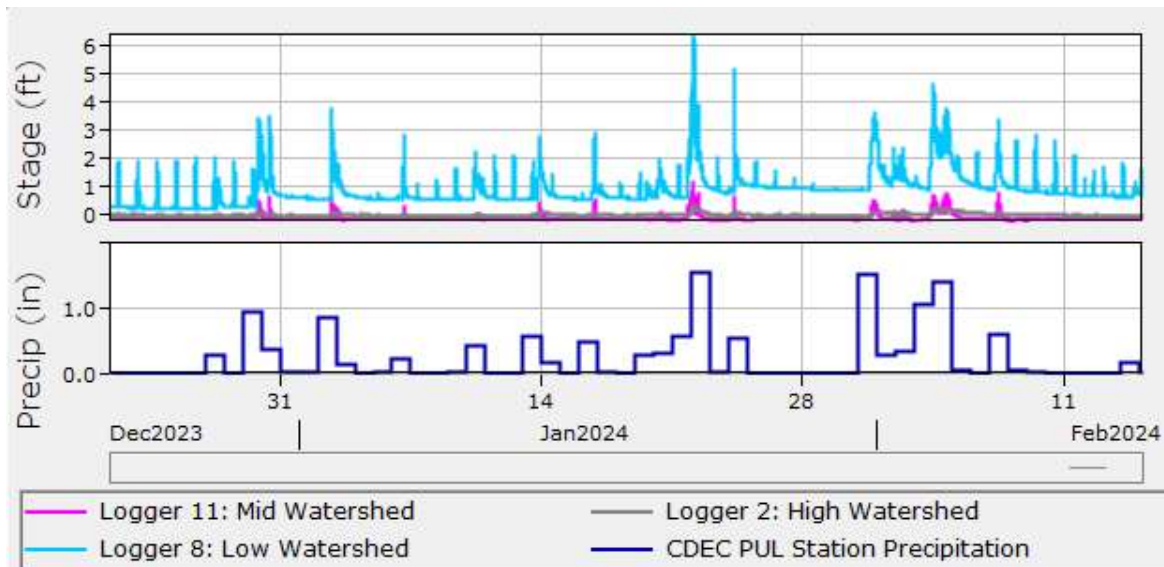
Exhibit 6. WRA Logger 2, 8, and 11 water level data and CDEC PUL station hourly precipitation

A calibration model scenario was developed by utilizing precipitation and water level logger data from January 21, 2024 to January 22, 2024. The January 21/22, 2024 storm event yielded the greatest cumulative precipitation depth where logger data was available. The relation between precipitation and flow in the upper, mid, and lower sections of the Pulgas Creek watershed represented by loggers 2, 11, and 8, respectively, can be seen in Exhibit 6. No flooding was reported during the period of recorded logger data.

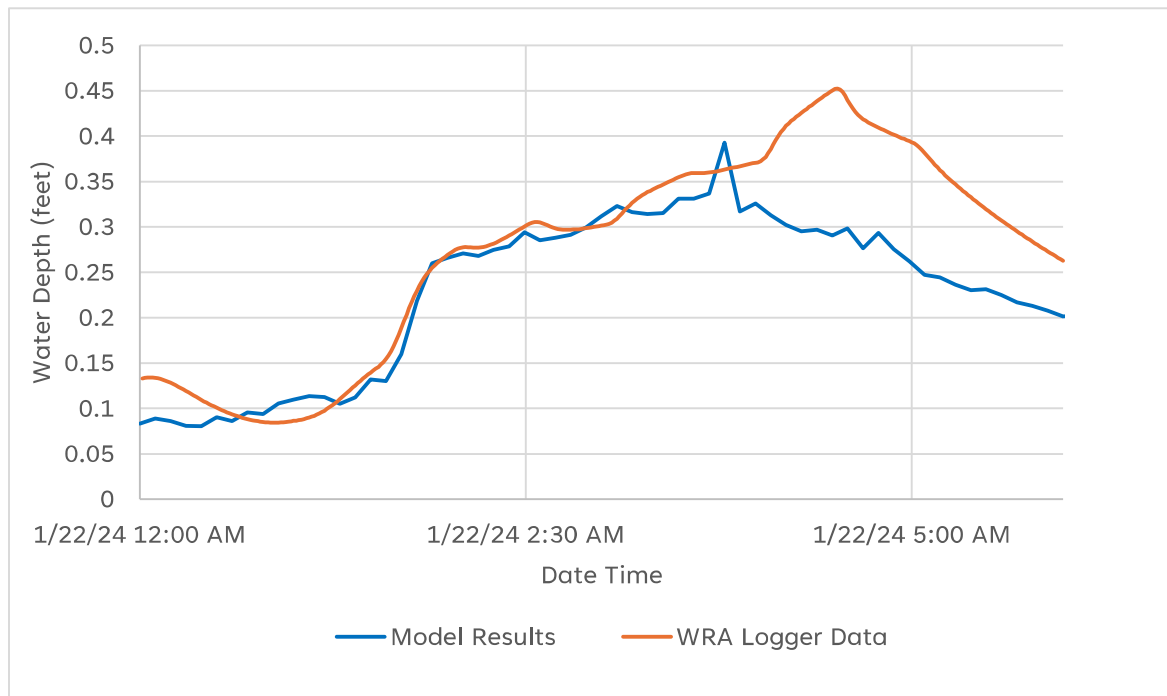
Exhibit 7. Logger 2 high watershed calibration model results and measured depth data

Modeled depths and timings roughly match logger data in the high watershed of Pulgas Creek based on Logger 2 observations (Exhibit 7). As expected, due to reports of landslides in Brittan Creek and substantial sediment mobilizing in the Brittan creek watershed, Logger 11 observations at the Alameda De Las Pulgas bridge demonstrate higher observed depth values than model outputs (Exhibit 8). This variance from model output to observations should be expected throughout Brittan Creek until high sediment loads are no longer expected to enter Brittan Creek or nearby storm drain conduits and sediment within the system is removed. Modeled depths downstream of Old County Road roughly match logger data in magnitude and timing. Observed values from Logger 8 show similar patterns as the model output with a slightly lower peak value and shorter time of concentration suggesting the watershed may have slightly more attenuation of the peak flow but also less detention than the model (Exhibit 9).

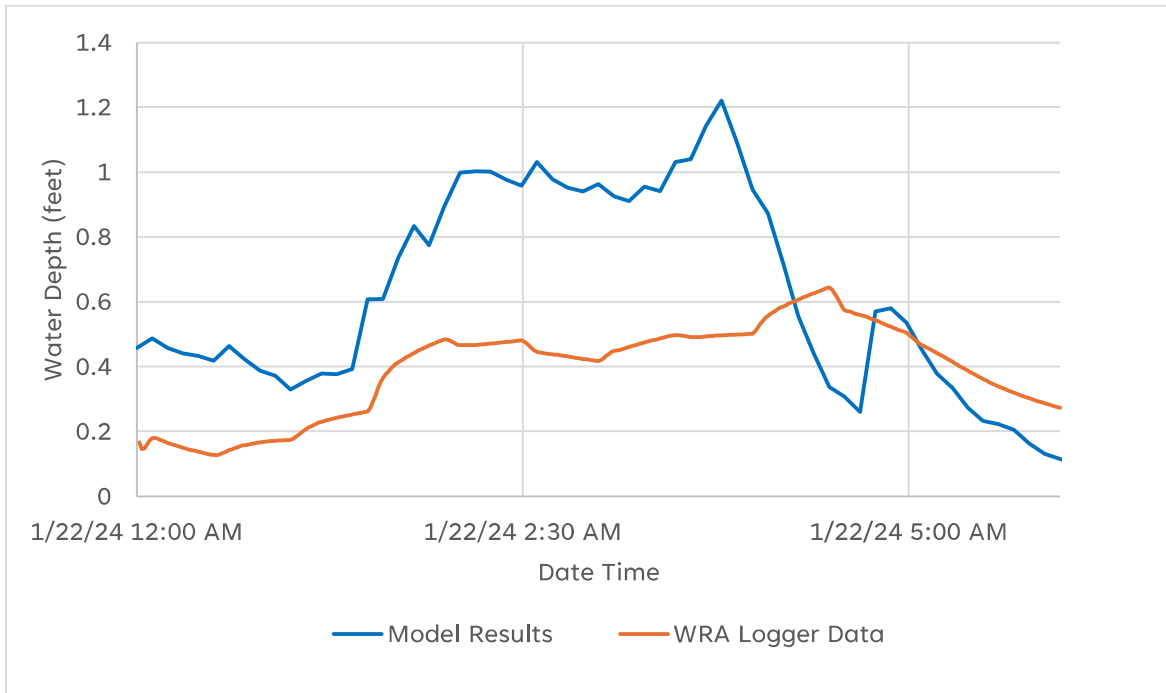
Exhibit 8. Logger 11 mid watershed calibration model results and measured depth data

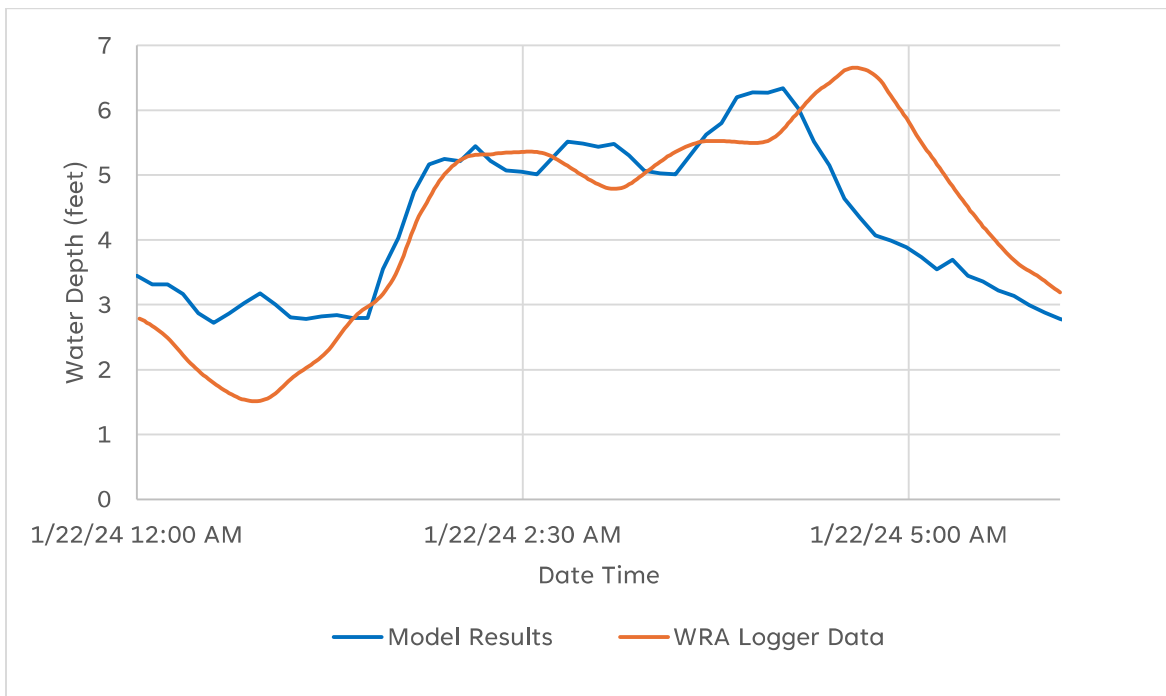
Exhibit 9. Logger 8 low watershed calibration model results and measured depth data

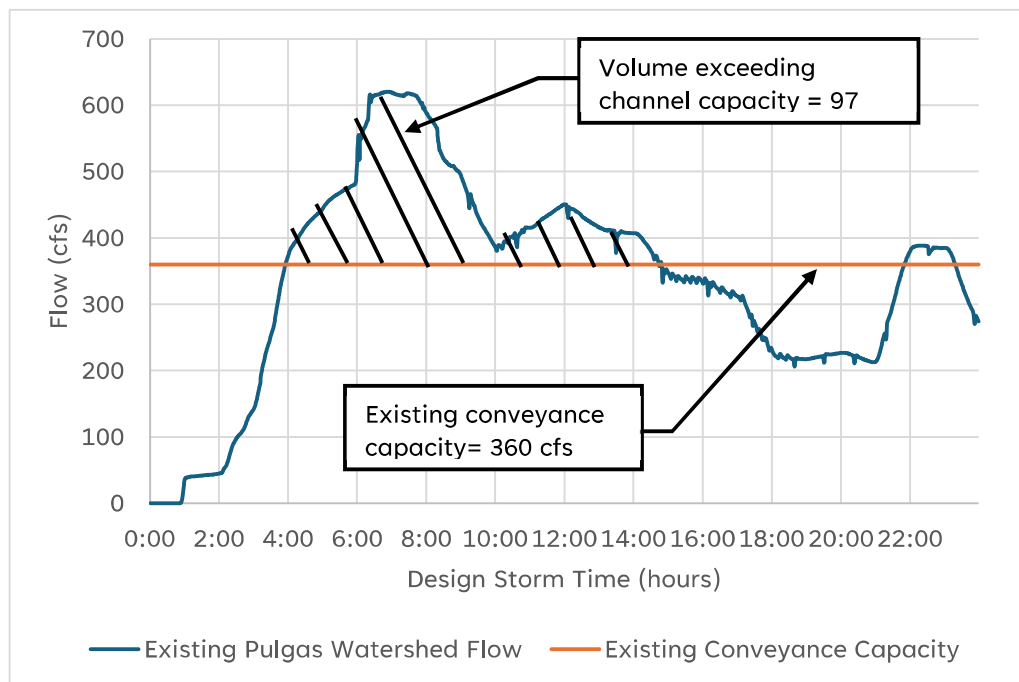
Model results indicate the existing capacity downstream of Old County Road is approximately 360 cfs resulting in 97 acre-ft of stormwater floods the surrounding area (*Exhibit 10*). Two options which are likely infeasible are to:

Exhibit 10. 100-year Hydrograph of Pulgas Creek downstream of Old County Road

1. increase capacity to approximately 650 cfs or
2. add detention basins to temporarily hold 97-acre feet of stormwater in the watershed for approximately four hours.

1. increase capacity to 500 cfs and
2. add detention basins to temporarily hold approximately 60 acre-feet of stormwater in the watershed for approximately four hours.

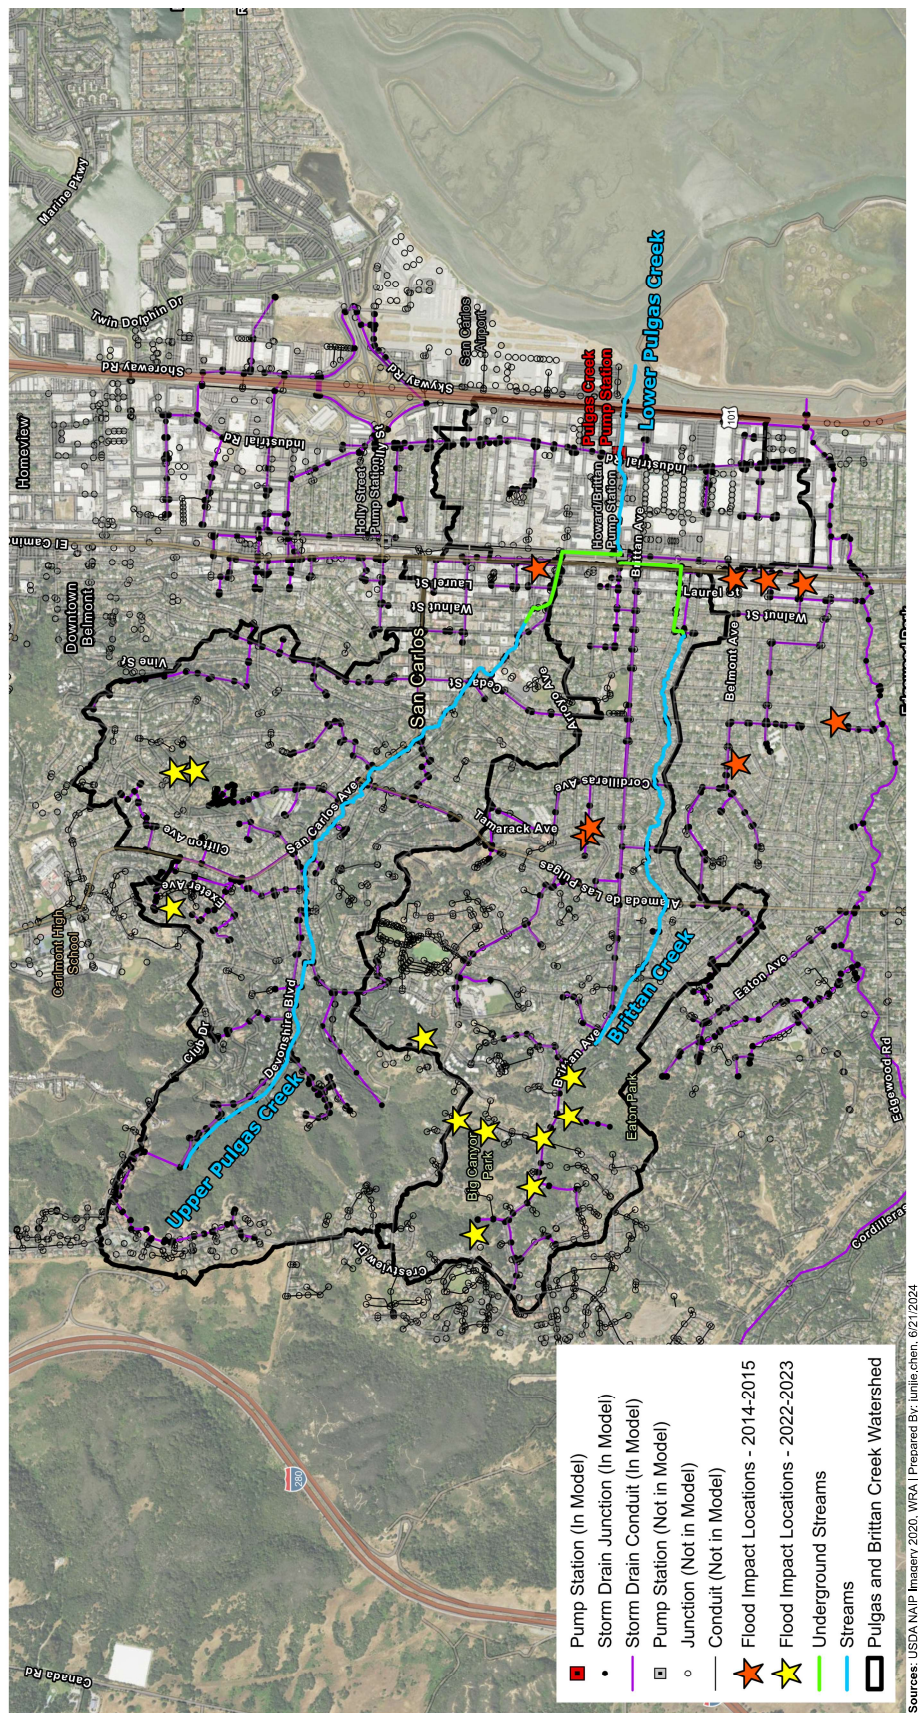
Figure 3. Pulgas Watershed Regions Impacted by Flooding

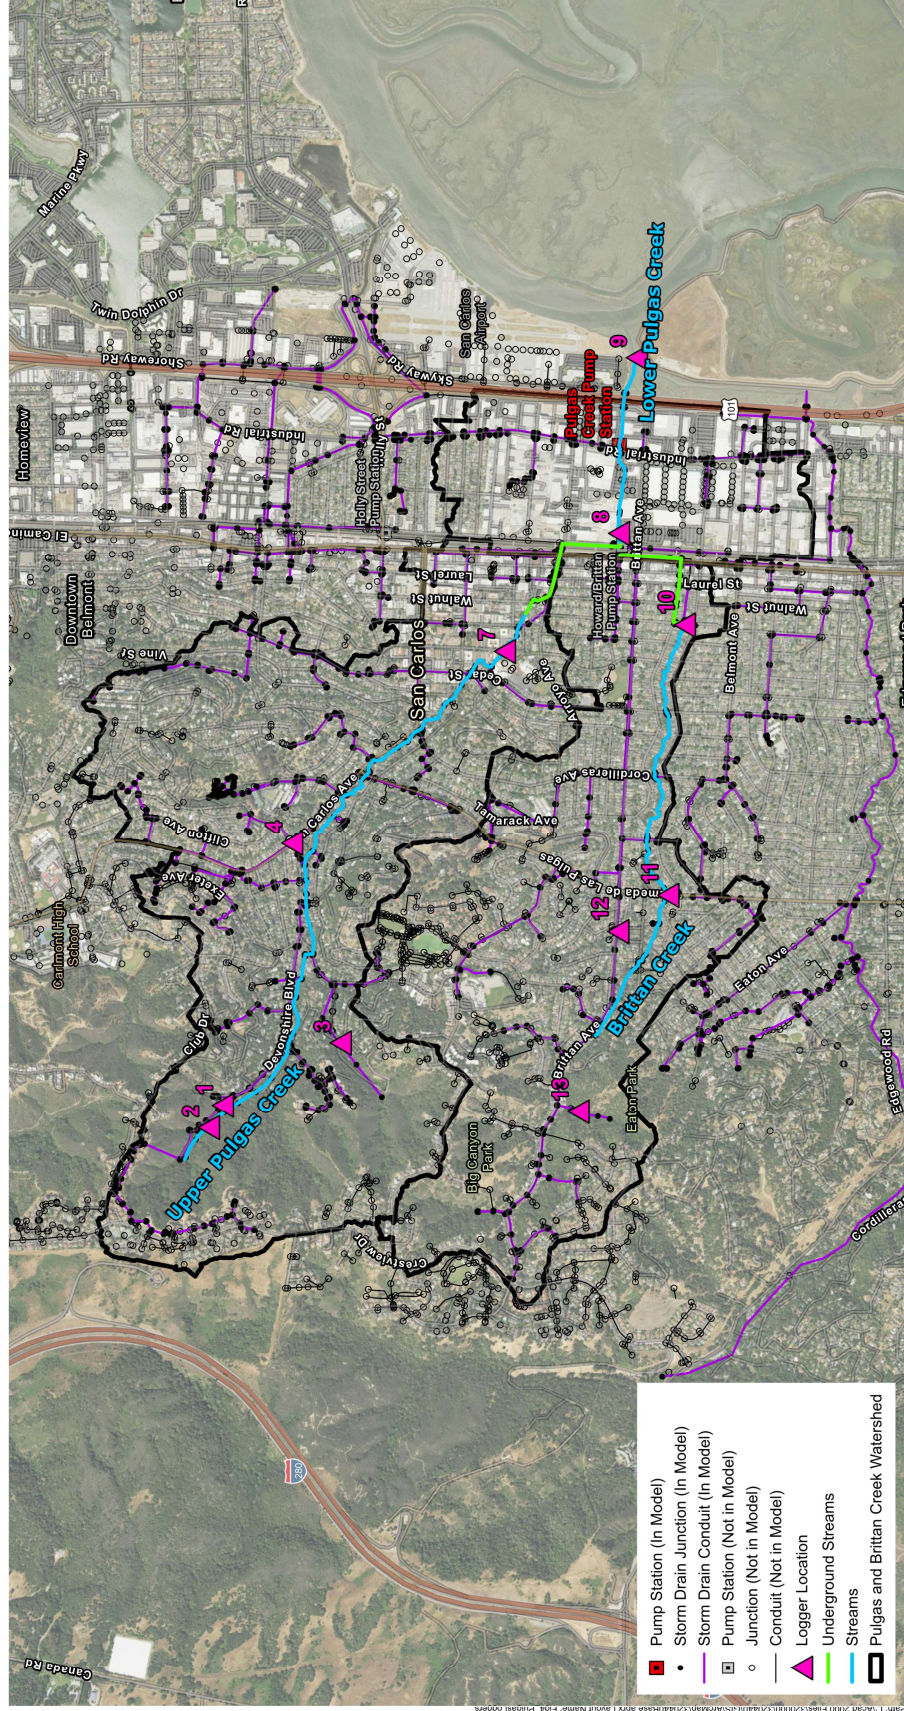
Figure 4. Storm Drain System Logger Locations

WRA installed a total of two barologgers and 11 water level loggers on December 20, 2023 to provide site-specific water level data around the Pulgas watershed for model calibration. Each barologger unit records barometric pressure for use in compensating for local atmospheric effects on the water level loggers' measurements. Each water level logger records water depth and temperature using a pressure sensor and temperature detector, respectively. The data loggers record pressure representing the height of water above the transducer sensor elevation. Water levels below the data logger sensors are not able to be measured. Loggers were placed along the low point of the selected feature (creek bottom, culvert invert, storm drain invert) and record levels in 6-minute intervals. The logger locations installed are shown in Figure 4. Loggers are labeled from number 1 to 13, with Loggers 5 and 6 omitted as the sites did not meet expectations for yielding usable data. Descriptions of the logger location, conditions, and purpose are provided in Table 1.

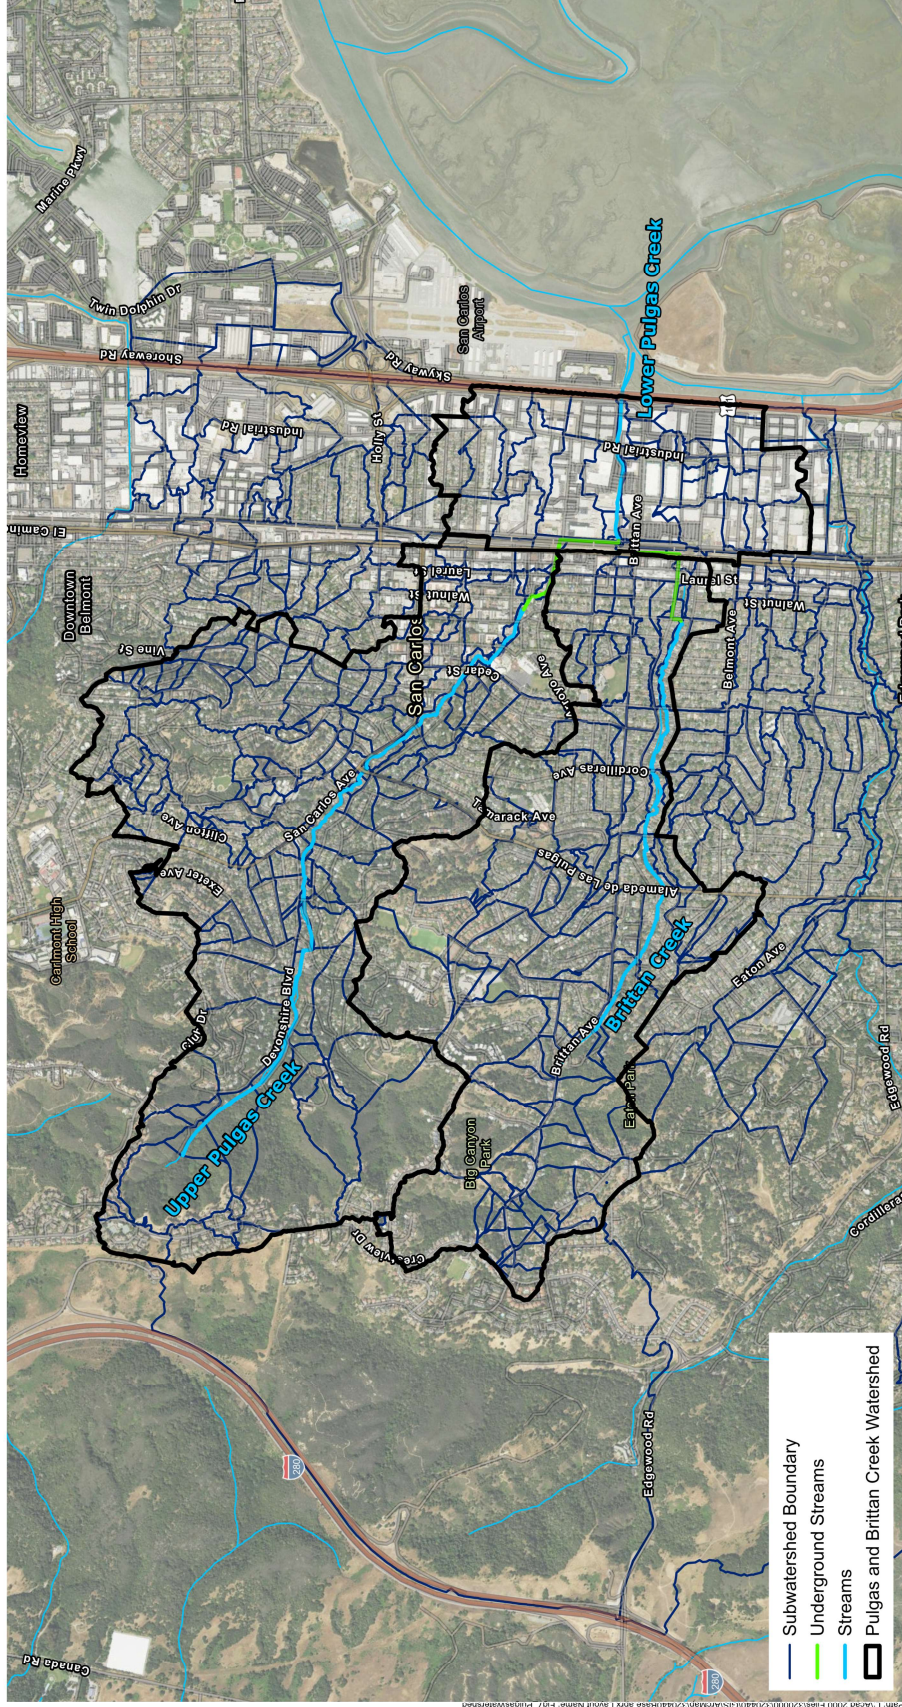
Figure 5. Sub-watersheds - Pulgas Creek Watershed

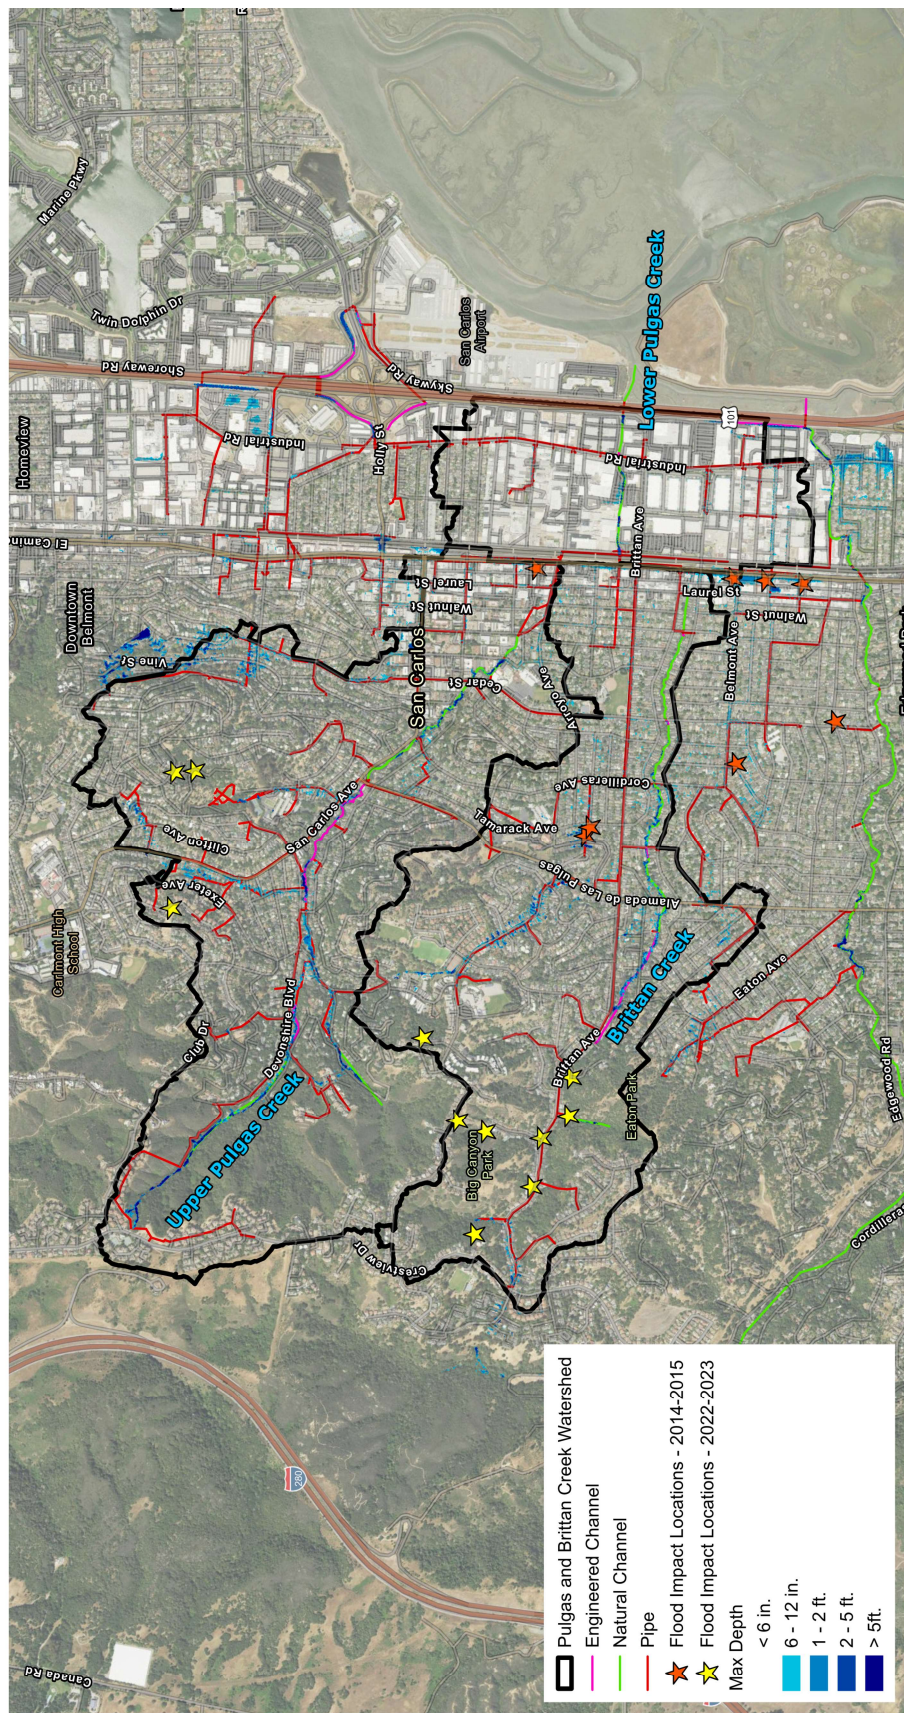
Figure 7. 25-year Flood Event (AMC II) Base Conditions

A map view of the 10-year storm event shows flooding in the lower watershed with depths in the surrounding parking lots and roads ranging from 0.5 to 1.5 feet (Figure 6). A map view of the 25-year storm event shows flooding in the lower watershed with depths in the surrounding parking lots and roads ranging from 0.5 to 2.5 feet (Figure 7). A map view of the 100-year storm event shows flooding in the lower watershed with depths in the surrounding parking lots and roads ranging from 0.5 to 2.5 feet (Figure 8).

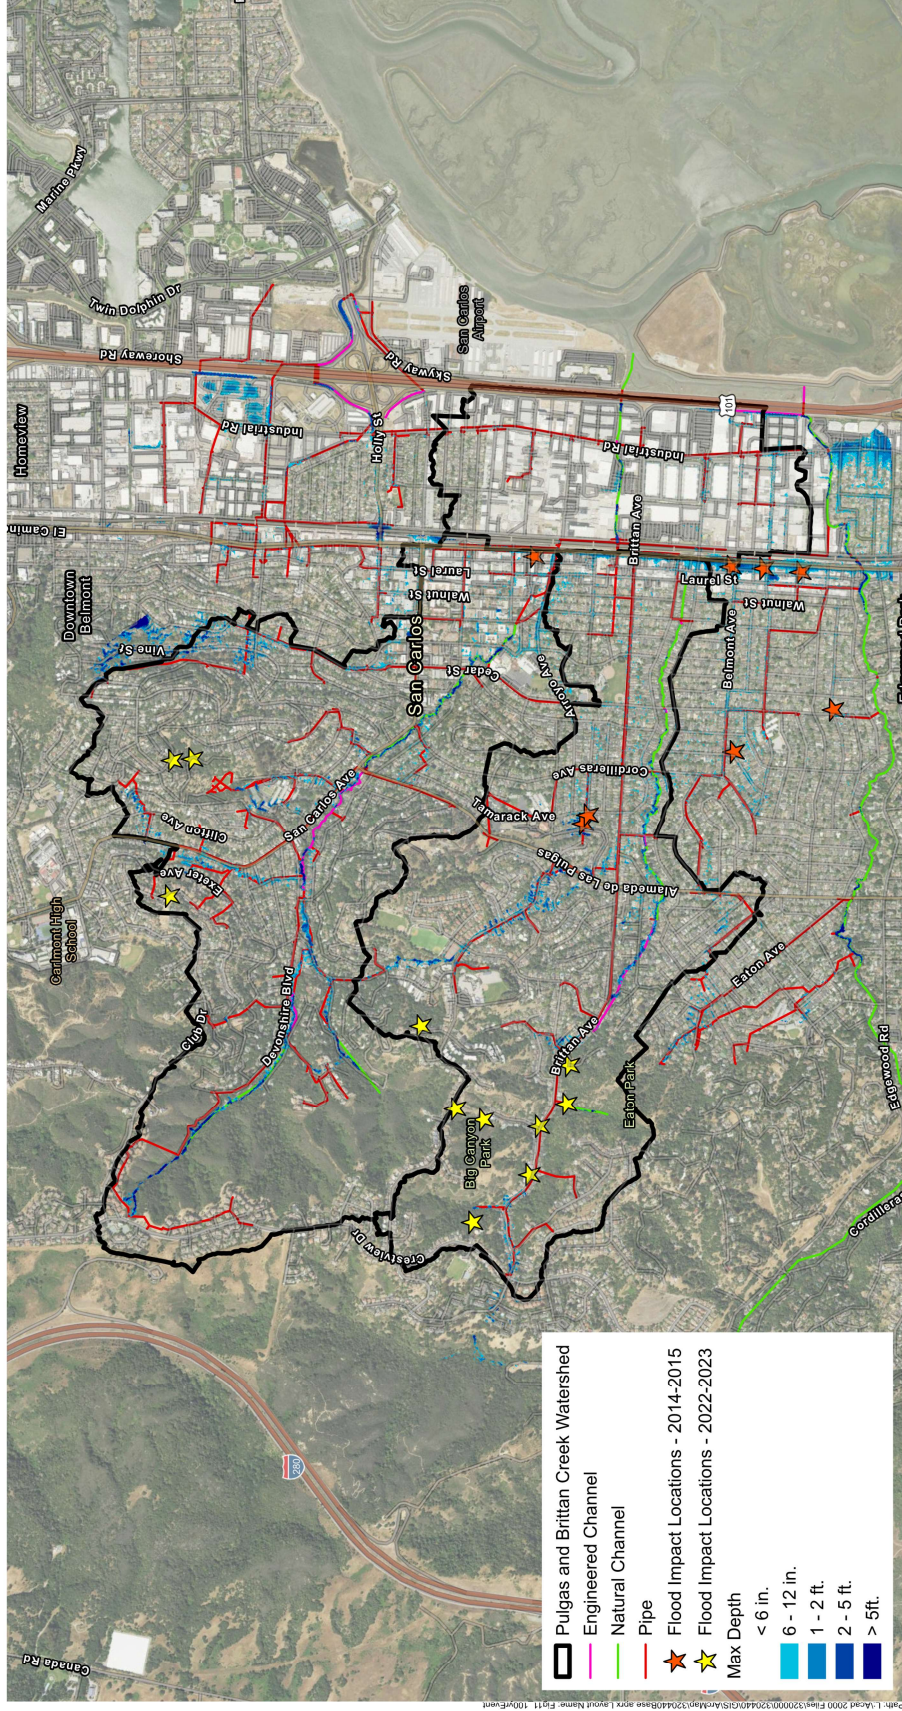
Figure 8. 100-year Flood Event (AMC II) Base Conditions

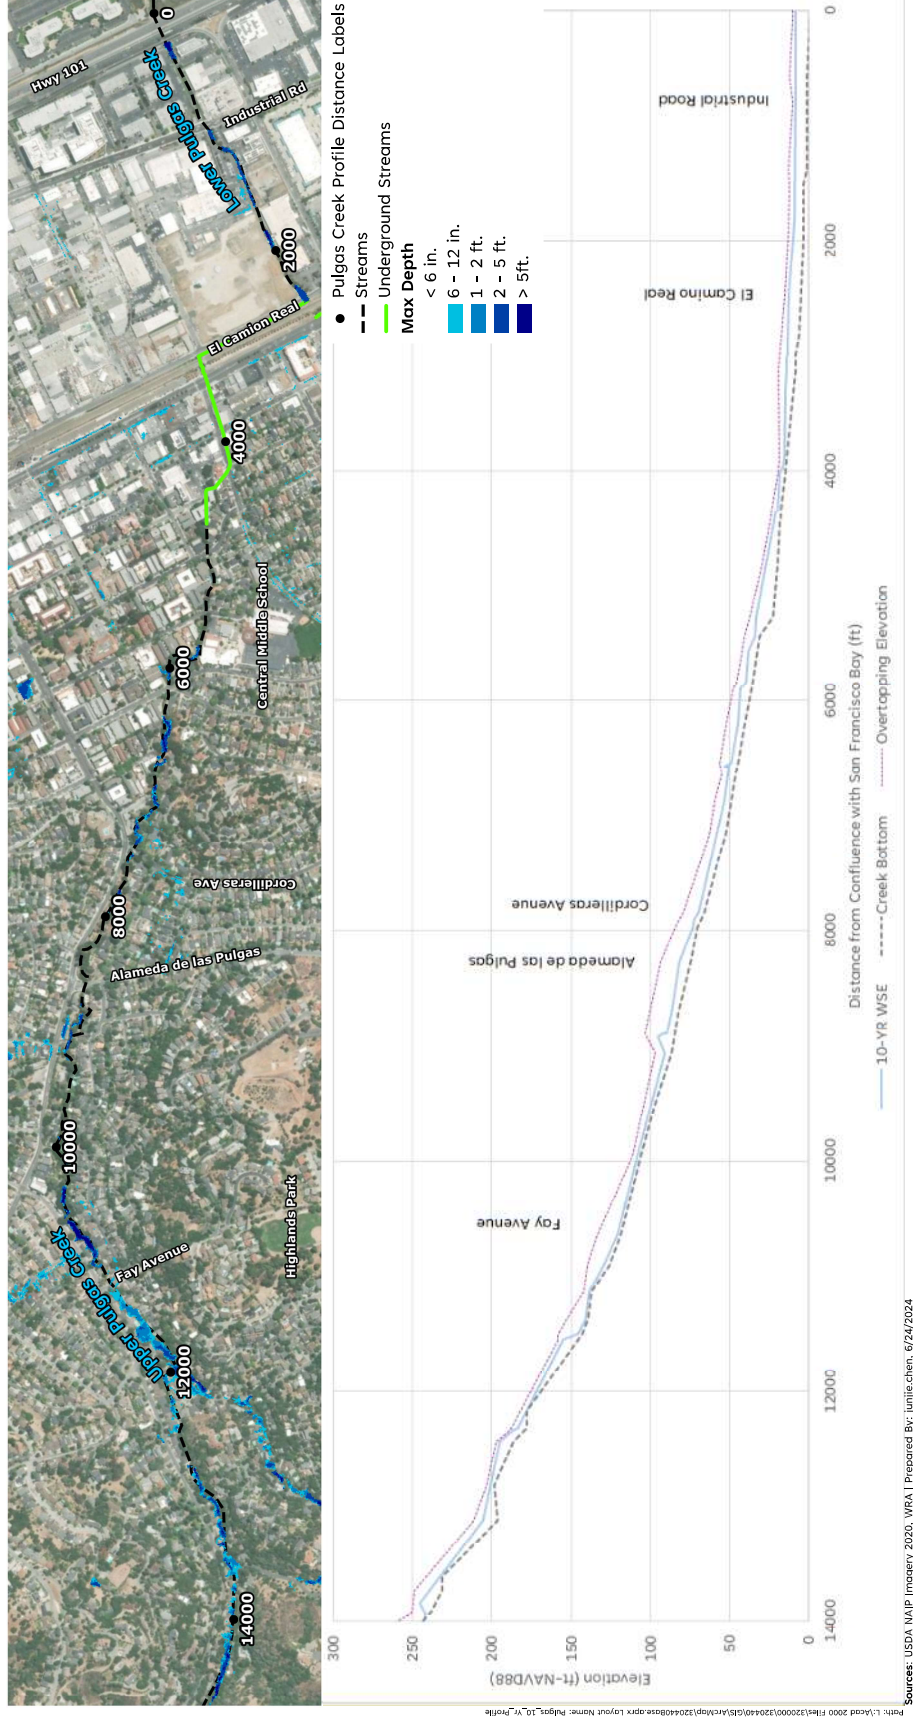
Figure 9. 10-Year Plan and Profile Views for Pulgas Creek

Results from the modeling suggest most of the high watershed has sufficient storm drain capacity to prevent flooding. Profile view results of depths along the Pulgas Creek alignment from the headwaters to Smith Slough, and Brittan Creek alignment from the headwaters to the confluence with Brittan Creek at El Camino Real, are shown in Figure 9 to Figure 14 for each of the studied storm events. The profile views of Pulgas Creek show shallow depths in the upper and middle watershed in creek segments, with depths increasing in magnitude in the lower watershed. The profile views of Brittan Creek show a similar behavior to Pulgas Creek in the upper watershed, but an increase in depth in the middle watershed due to a change in channel slope from 2.5% to 1.5%. Pulgas Creek quickly conveys flows down to the lower watershed without an opportunity for water to pile up while Brittan Creek shows some attenuation behavior, retaining some flood waters in the middle watershed.

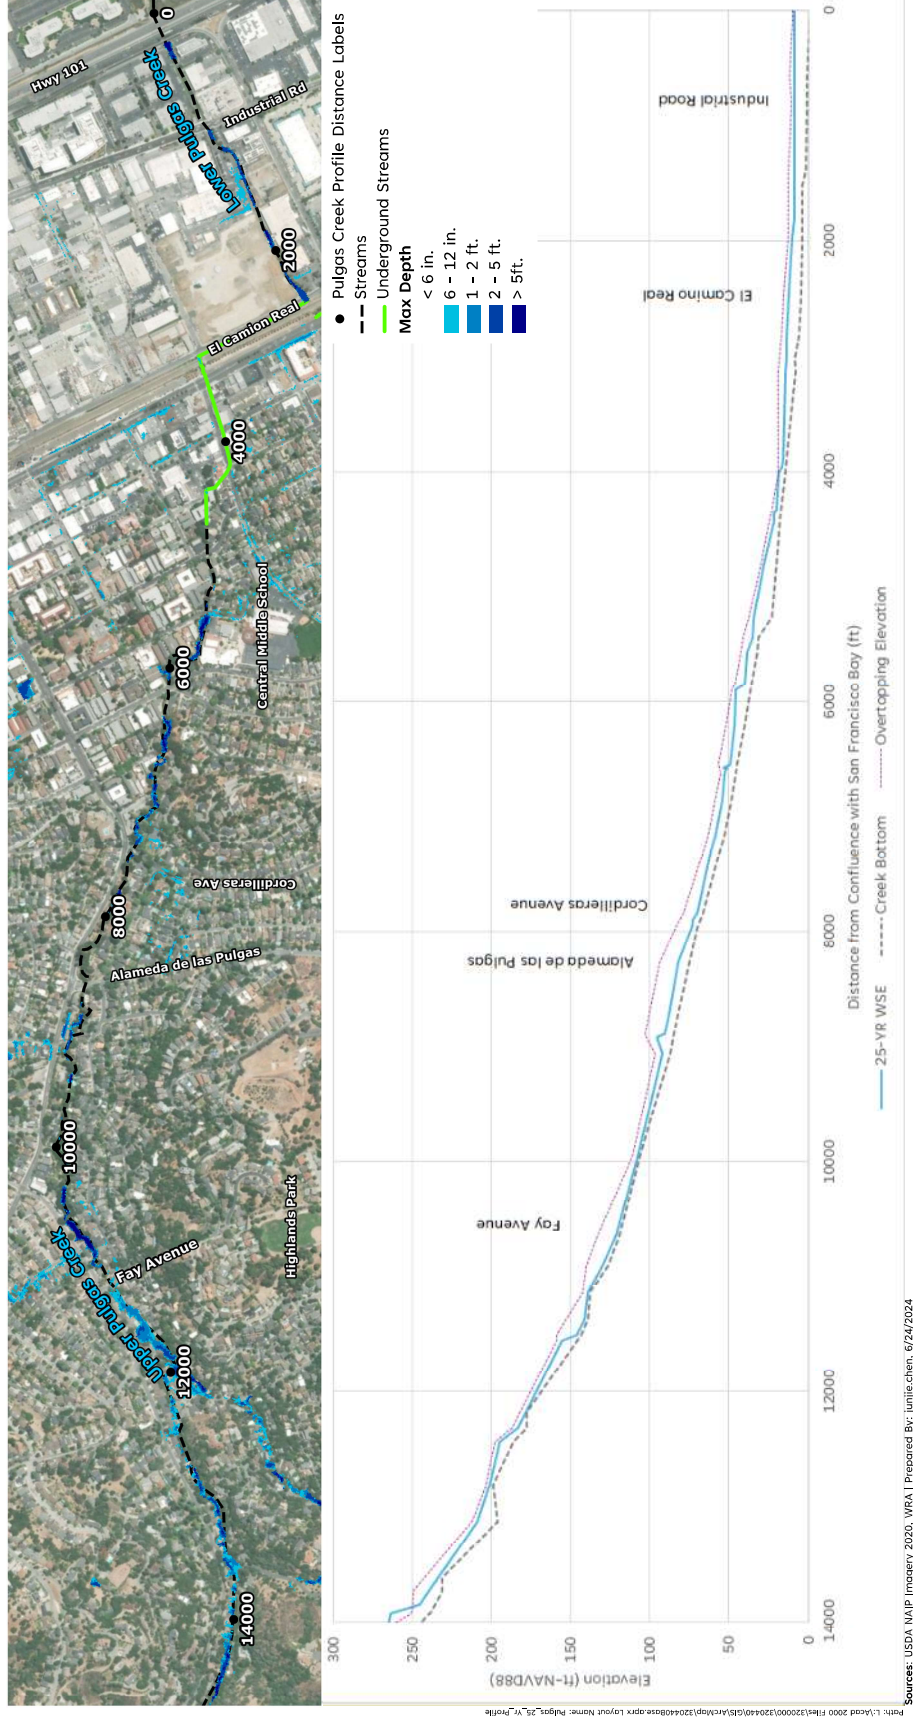
Figure 10. 25-Year Plan and Profile Views for Pulgas Creek

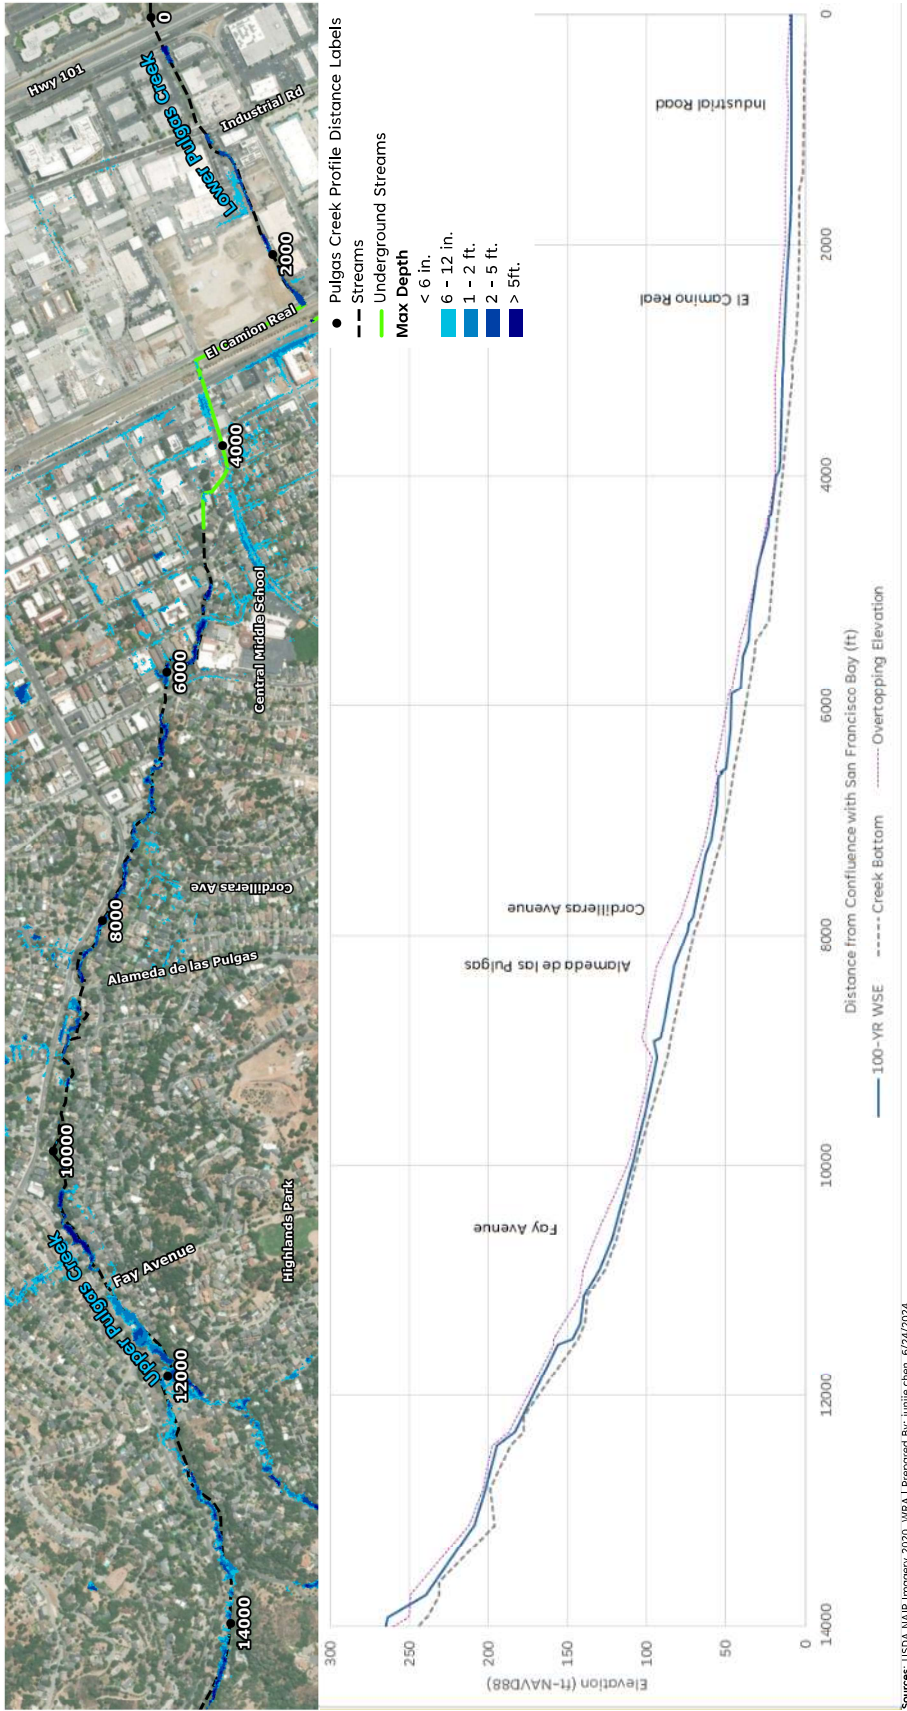
Figure 11. 100-Year Plan and Profile Views for Pulgas Creek
