Appendix A: Existing Conditions Hydraulics and Hydrology Memorandum

TO:	Grace Le, PE	FROM:	Andrew Smith, PE Angela Hogan, PE Chris Feng, PE
CC:	Camille Bandy, PE, QSD Freyer and Laureta	Jeff Tarantino, PE Freyer and Laureta	
DATE:	December 19, 2024		
SUBJECT:	Pulgas Creek Watershed Study: Existing Conditions Hydraulics and Hydrology Memorandum Rev. 1

Pulgas Watershed Study
Existing Conditions H&H Memo
City of San Carlos, San Mateo, CA

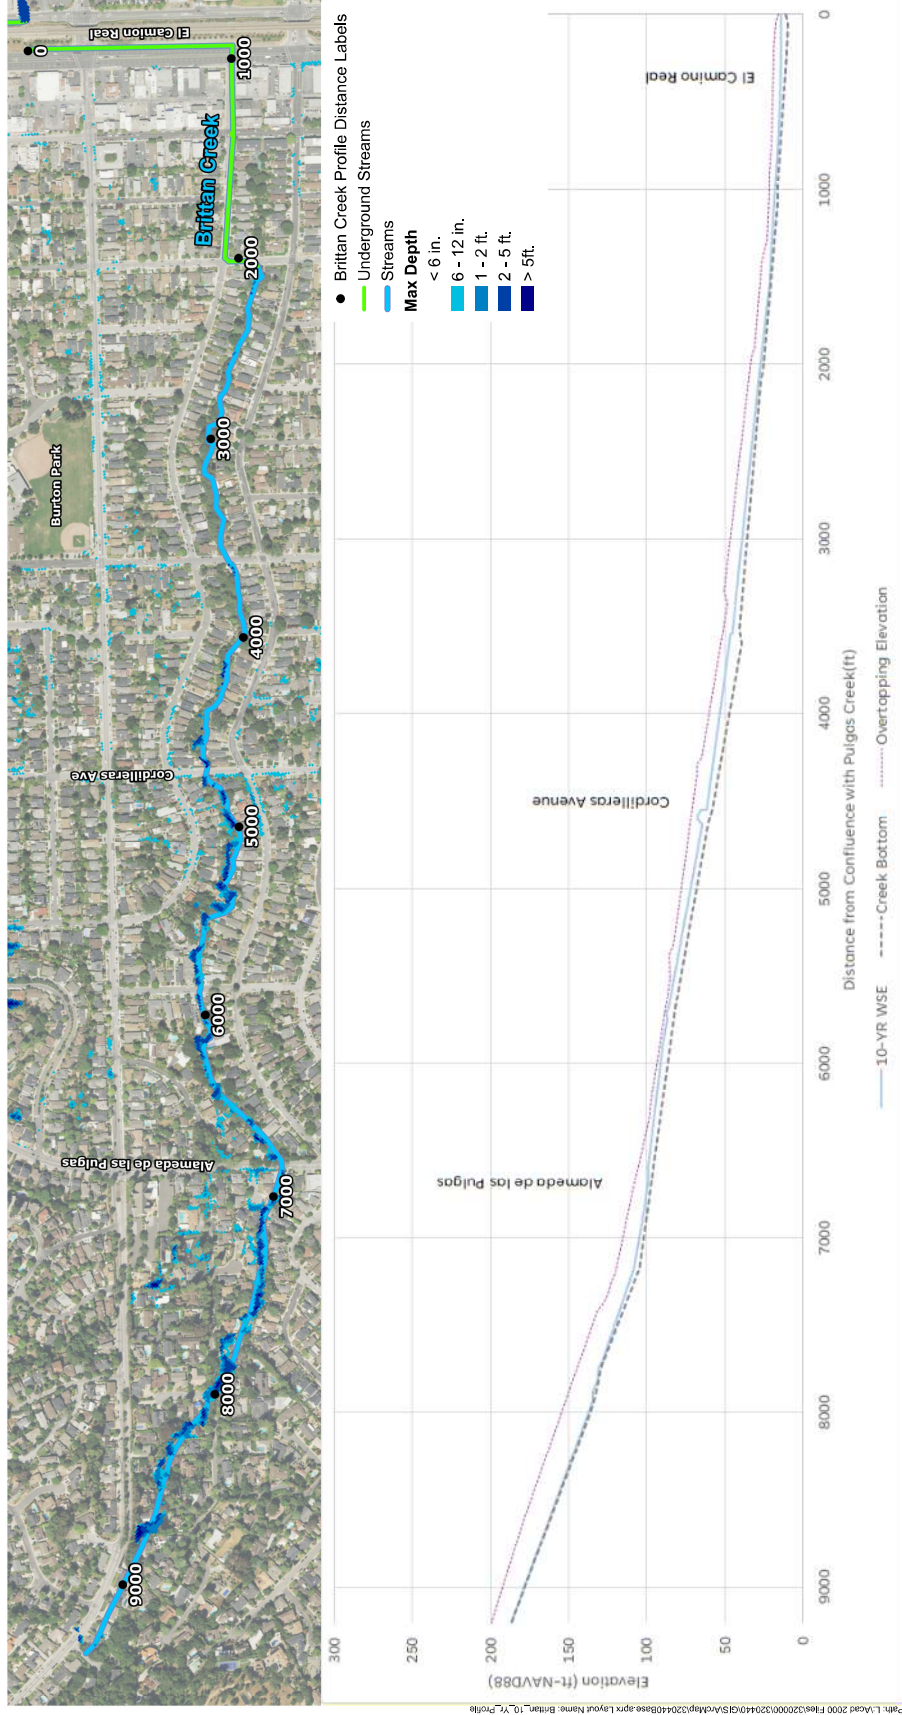
Figure 12. 10-Year Plan and Profile Views for Brittan Creek

Results from the modeling suggest most of the high watershed has sufficient storm drain capacity to prevent flooding. Profile view results of depths along the Pulgas Creek alignment from the headwaters to Smith Slough, and Brittan Creek alignment from the headwaters to the confluence with Brittan Creek at El Camino Real, are shown in Figure 9 to Figure 14 for each of the studied storm events. The profile views of Pulgas Creek show shallow depths in the upper and middle watershed in creek segments, with depths increasing in magnitude in the lower watershed. The profile views of Brittan Creek show a similar behavior to Pulgas Creek in the upper watershed, but an increase in depth in the middle watershed due to a change in channel slope from 2.5% to 1.5%. Pulgas Creek quickly conveys flows down to the lower watershed without an opportunity for water to pile up while Brittan Creek shows some attenuation behavior, retaining some flood waters in the middle watershed.

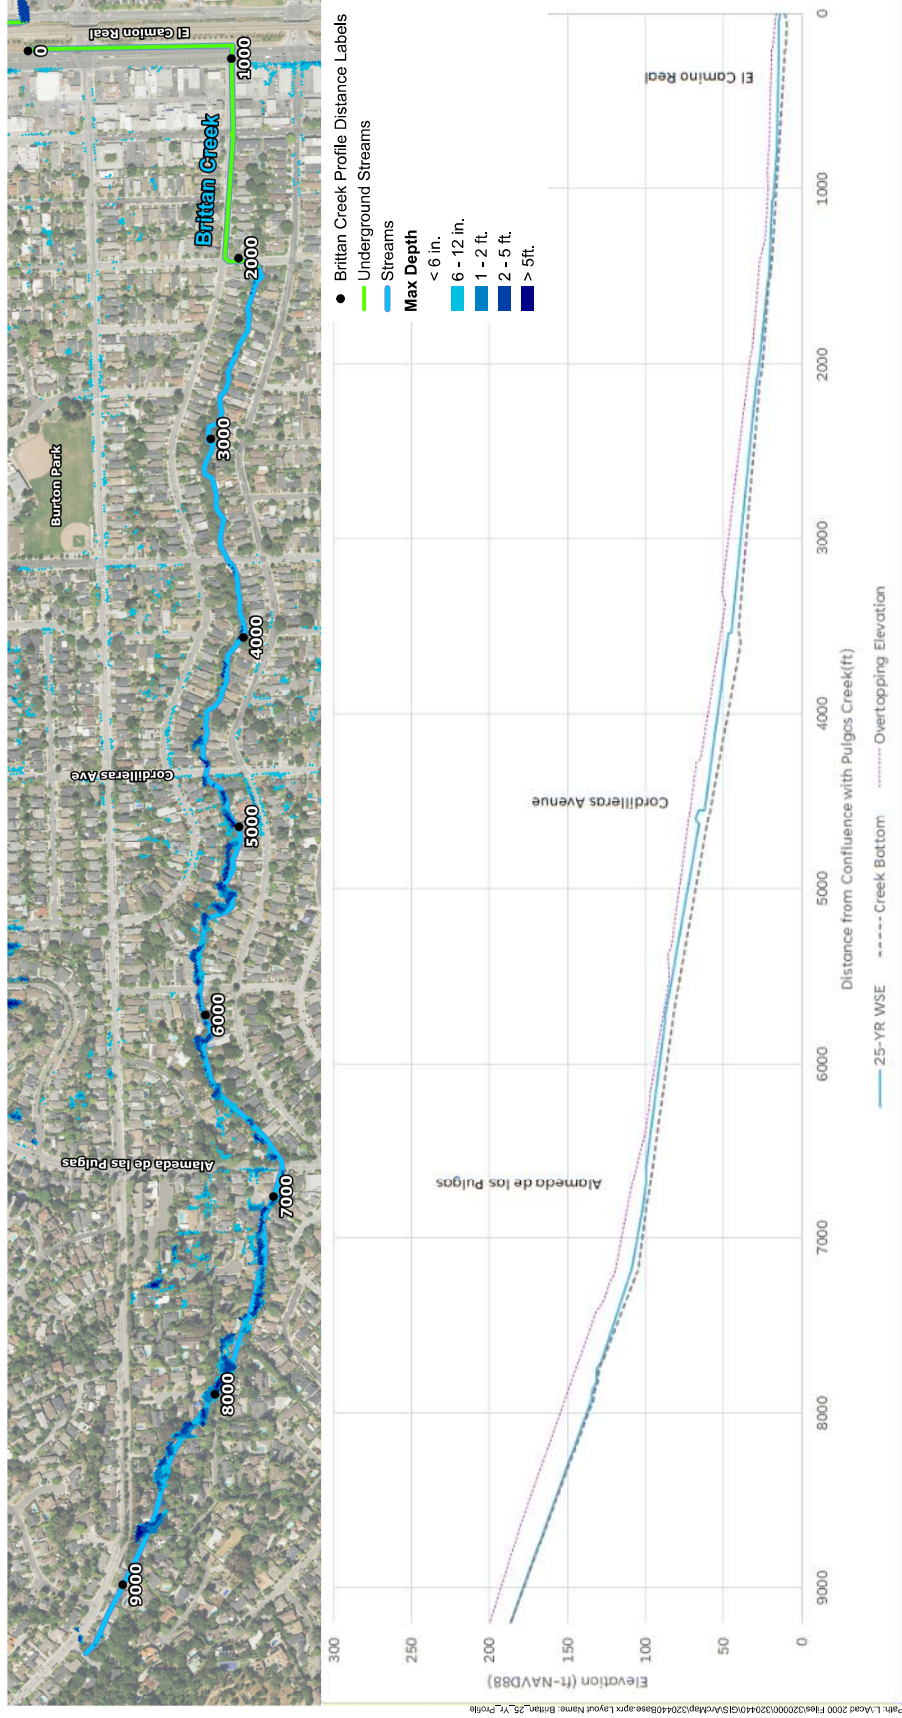
Figure 13. 25-Year Plan and Profile Views for Brittan Creek

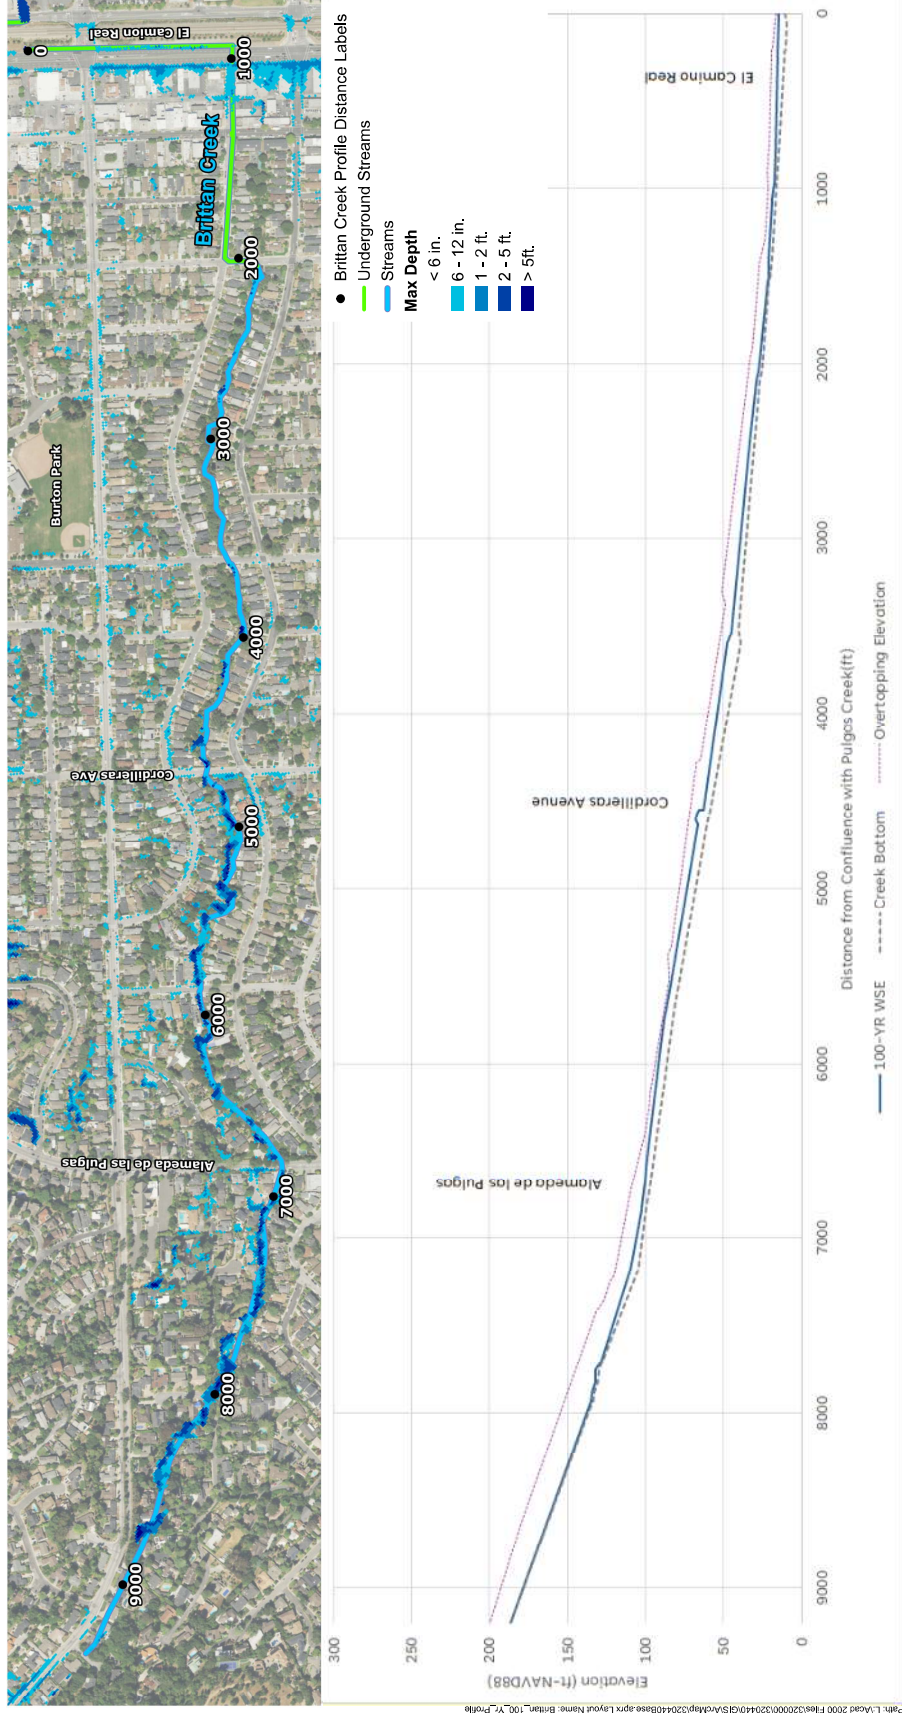
Figure 14. 100-Year Plan and Profile Views for Brittan Creek
