Crosswalk Warrants for Alameda de Las Pulgas/Hilltop Drive and 1650 Industrial Road

As requested, W-Trans has prepared a warrant analysis to determine the potential need for new pedestrian crosswalks at two locations in the City of San Carlos: Alameda de Las Pulgas/Hilltop Drive and midblock near 1650 Industrial Road (24-hour Fitness). The purpose of this letter is to document the existing conditions, data obtained, analysis performed, and present the results of the evaluation.

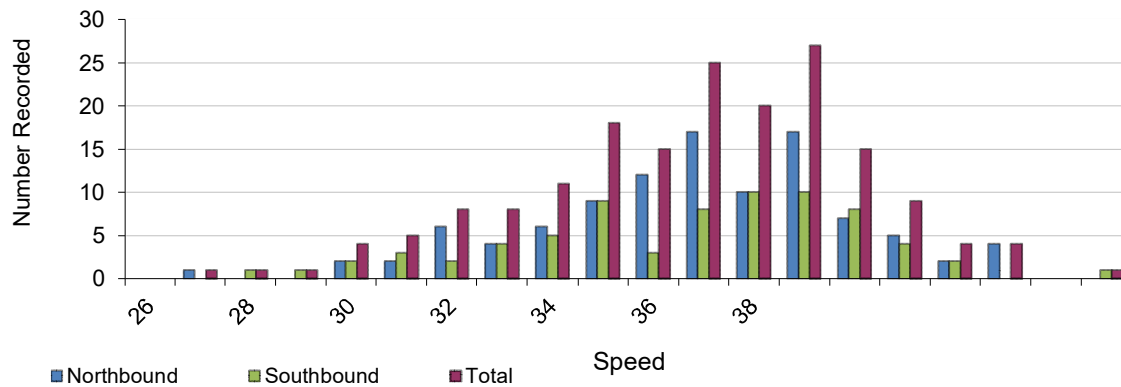
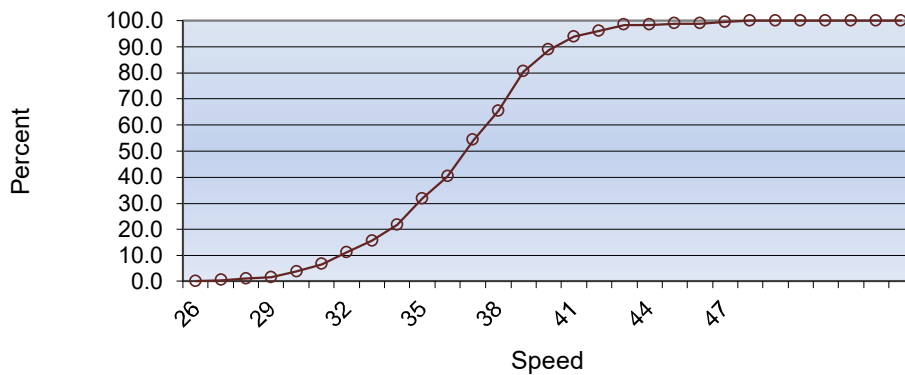
San Carlos, CA Speed Survey

Street: Alameda de Las Pulgas **From:** Saint Francis Way **To:** Hilltop Dr

Overall	Vehicles Sampled:	179
	85th Percentile Speed:	35 mph
	Mean (50th Percentile) Speed:	32 mph
	Pace:	26 to 36 mph
Northbound	Vehicles Sampled:	105
	85th Percentile Speed:	35 mph
	Mean (50th Percentile) Speed:	32 mph
	Pace:	27 to 37 mph
Southbound	Vehicles Sampled:	74
	85th Percentile Speed:	35 mph
	Mean (50th Percentile) Speed:	32 mph
	Pace:	27 to 37 mph

Speed Profile

Cumulative Speed Profile

At the time of the site visit, a spot speed survey sampling of 179 vehicles on Alameda de Las Pulgas (74 in the southbound direction and 105 in the northbound direction), resulted in an 85th-percentile speed of 35 mph for both directions. These observed speeds are about 5 mph higher than the posted speed limit of 30 mph. On Industrial Road, a speed survey sampling 174 vehicles (71 in the southbound direction and 103 in the northbound direction) resulted in an 85th-percentile speed of 39 mph for southbound and 41 mph for northbound travel. These observed speeds are about 5 mph higher than the posted speed limit of 35 mph. A summary of individual speed measurements is enclosed for both locations.

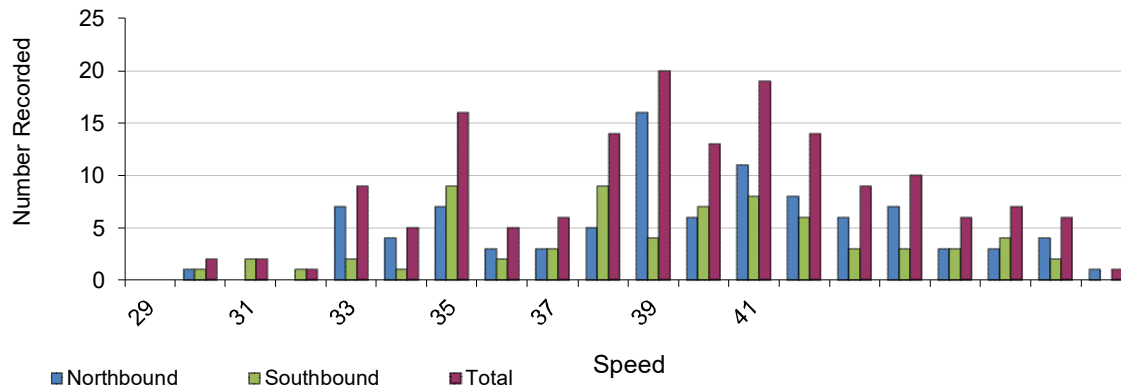
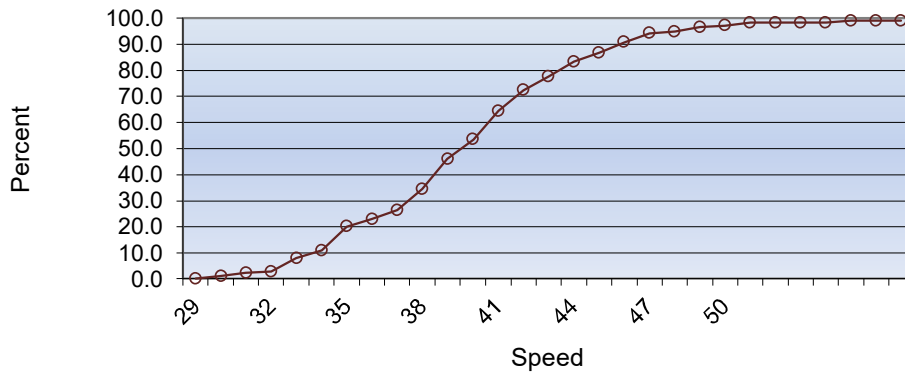
San Carlos, CA Speed Survey

Street: Industrial Road

Overall	Vehicles Sampled:	174
	85th Percentile Speed:	40 mph
	Mean (50th Percentile) Speed:	35 mph
	Pace:	29 to 39 mph
Northbound	Vehicles Sampled:	103
	85th Percentile Speed:	41 mph
	Mean (50th Percentile) Speed:	35 mph
	Pace:	29 to 39 mph
Southbound	Vehicles Sampled:	71
	85th Percentile Speed:	39 mph
	Mean (50th Percentile) Speed:	35 mph
	Pace:	29 to 39 mph

Speed Profile

Cumulative Speed Profile

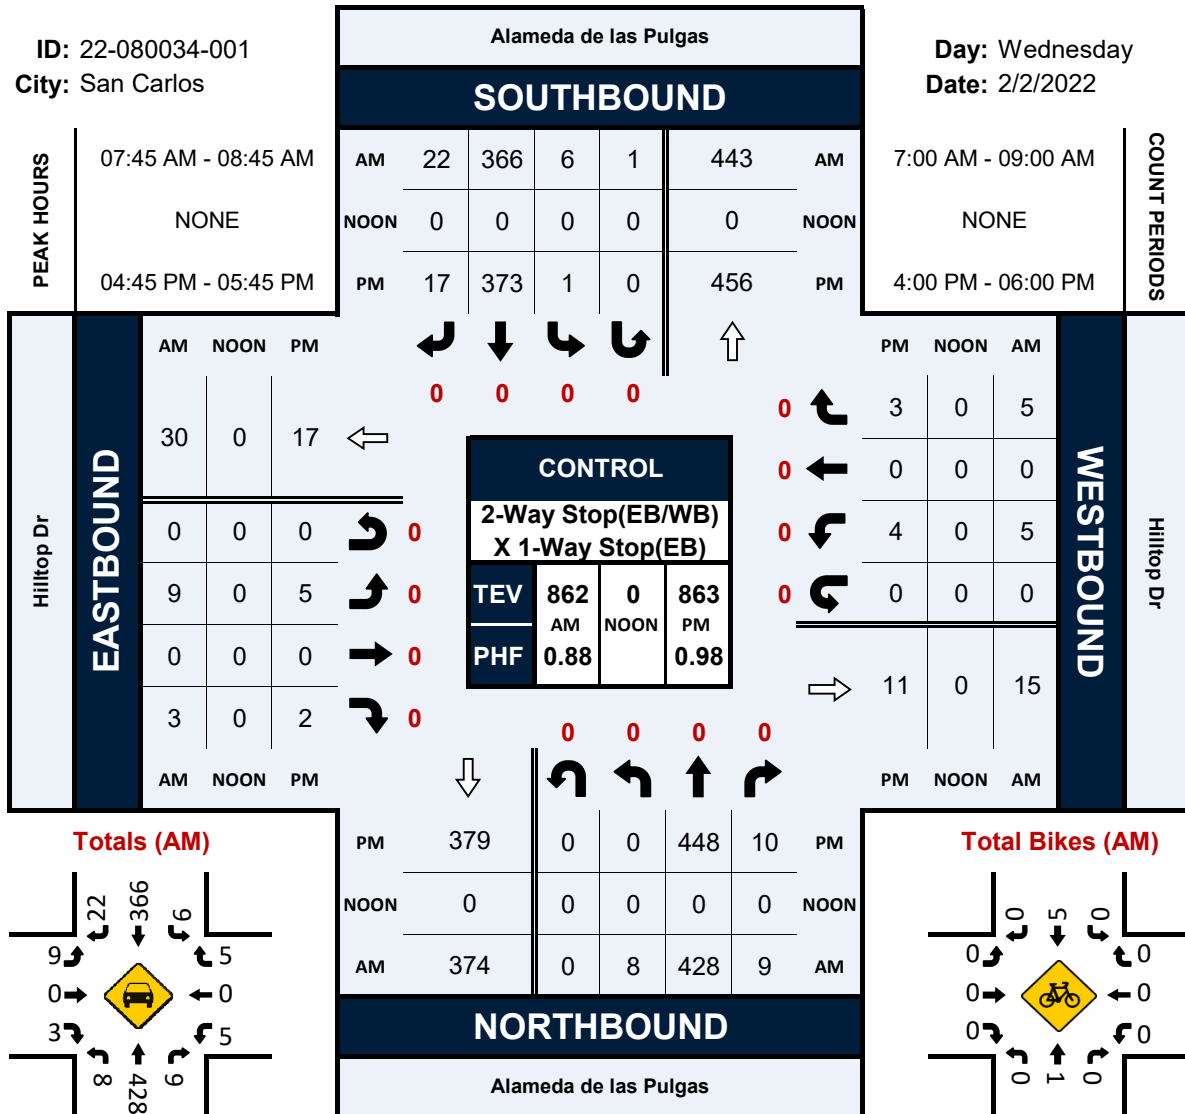
Alameda de las Pulgas & Hilltop Dr

Peak Hour Turning Movement Count

Vehicle, bicycle, and pedestrian turning movement counts were also conducted at Alameda de Las Pulgas/Hilltop Drive on Wednesday, February 2, 2022, from 7:00 to 9:00 a.m. and 4:00 to 6:00 p.m. For both the a.m. and p.m. count periods, fourteen bicycle trips were observed through the intersection in addition to thirty-eight pedestrian trips, four of which were pedestrian trips across Alameda de Las Pulgas during the a.m. peak hour. A summary of the turning movement counts is enclosed.

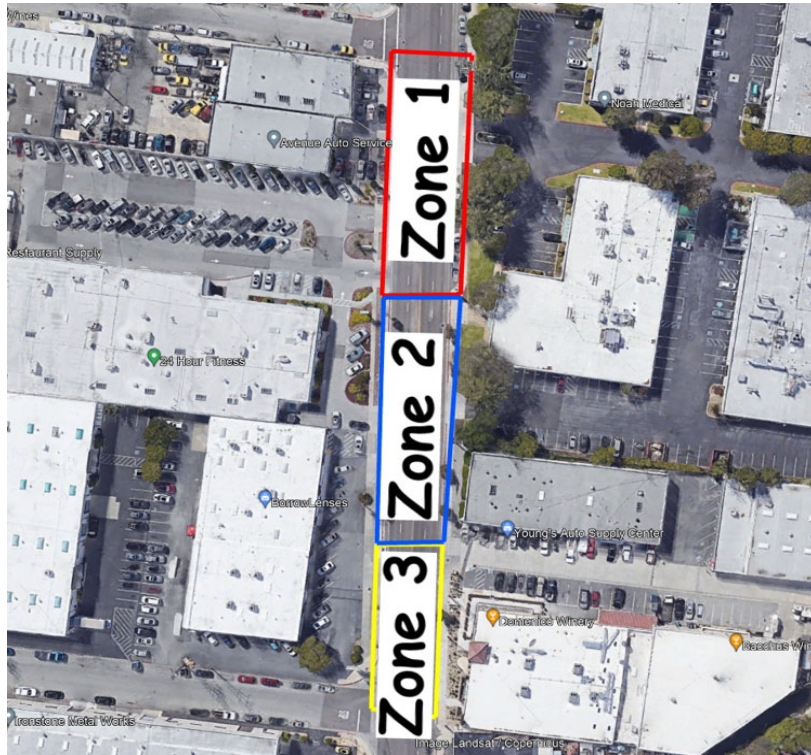
Crosswalk, Jaywalking Study

Location: Industrial Rd Bet. Washington St & Bing St
City: San Carlos

TIME	Peds					
	Zone 1		Zone 2		Zone 3	
	EB	WB	EB	WB	EB	WB
4:00 PM	0	3	0	1	2	2
4:15 PM	2	1	0	1	0	0
4:30 PM	1	1	0	0	0	1
4:45 PM	2	1	0	0	0	1
5:00 PM	1	2	0	0	0	0
5:15 PM	2	1	0	0	0	1
5:30 PM	0	2	0	1	0	0
5:45 PM	2	5	0	0	0	0
Totals	10	16	0	3	2	5

A pedestrian crossing study was conducted on Wednesday, February 2, 2022, between 4:00 and 6:00 p.m. in the vicinity of 1650 Industrial Road to determine where pedestrians are choosing to cross and how many pedestrians are currently utilizing the unmarked crossing along the segment of Industrial Road between Washington Street and Bing Street. Thirty-six pedestrians and three cyclists were observed crossing this segment of Industrial Road during the p.m. peak period, with nineteen pedestrians and one cyclist crossing in the peak hour between 4:00 and 5:00 p.m. The most popular crossing location, with 26 pedestrian crossings, was observed to be between Washington Street and the 24-hr Fitness driveway, north of 1650 Industrial Road. A summary of pedestrian and cyclist crossings is provided in Table 1.

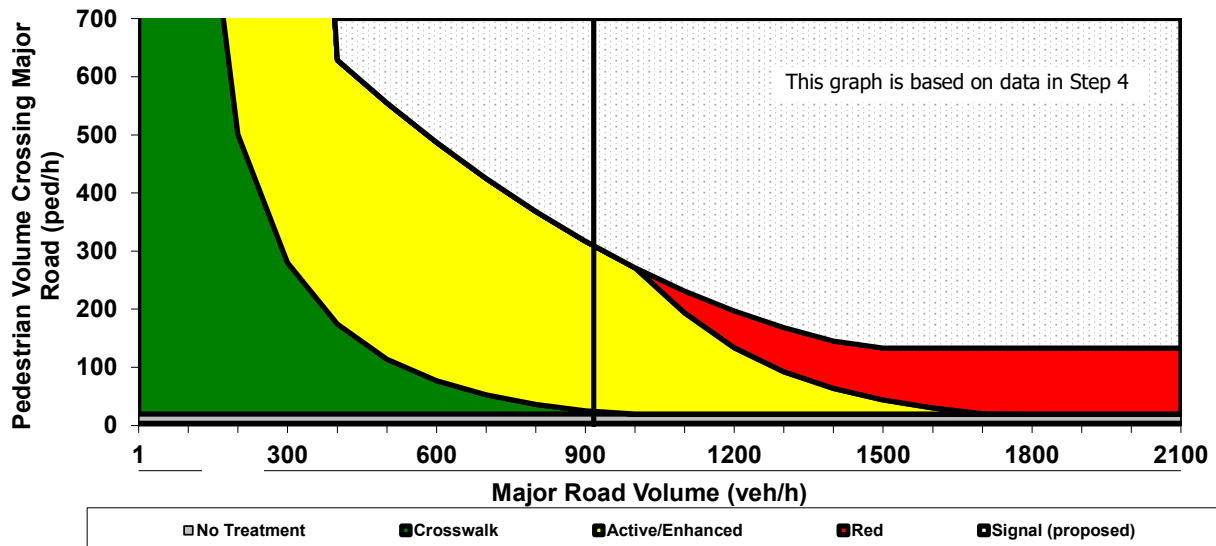
Major road flow rate (veh/s), v		4f	0.25
Average pedestrian delay (s/person), d_p		4g	188
Total pedestrian delay (h), D_p The value in 4h is the calculated estimated delay for all pedestrians crossing the major roadway without a crossing treatment (assumes 0% compliance). If the actual total pedestrian delay has been measured at the site, that value can be entered in 4i to replace the calculated value in 4h.		4h	0.2
		4i	
Step 5: Select treatment based up on total pedestrian delay and expected motorist compliance.			
Expected motorist compliance at pedestrian crossings in region: enter HIGH for High Compliance or LOW for Low Compliance		5a	HIGH
Treatment Category:		Consider raised median islands, curb extensions, traffic calming, etc. as feasible.

This worksheet provides general recommendations on pedestrian crossing treatments to consider at unsignalized intersections; in all cases, engineering judgment should be used in selecting a specific treatment for installation. This worksheet does not apply to school crossings. In addition to the results provided by this worksheet, users should consider whether a pedestrian treatment could present an increased safety risk to pedestrians, such as where there is poor sight distance, complex geometrics, or nearby traffic signals.

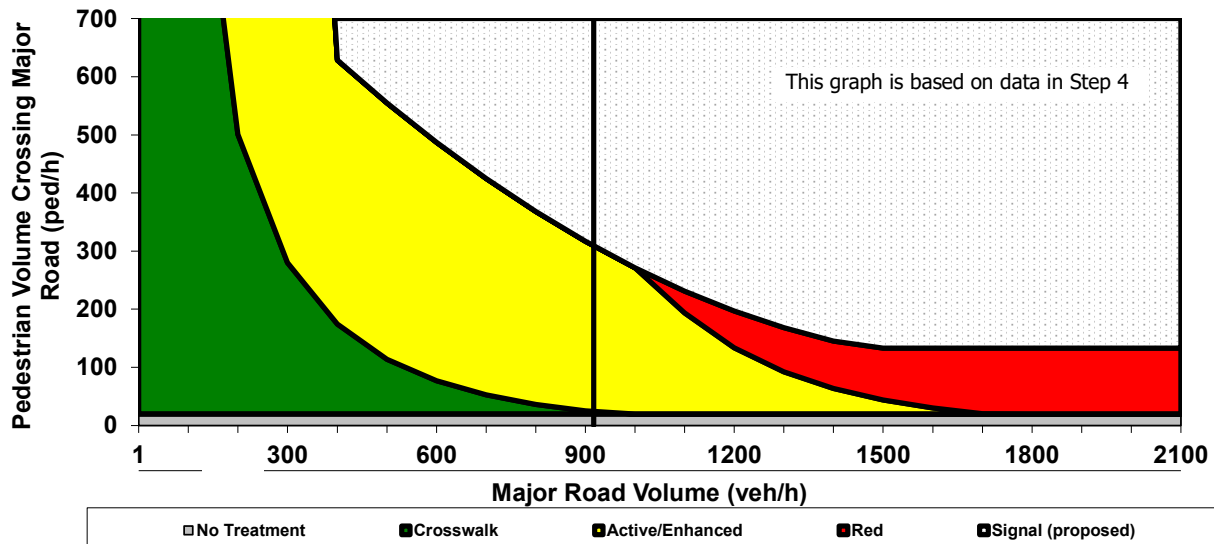
Total pedestrian delay (h), D_p The value in 4h is the calculated estimated delay for all pedestrians crossing the major roadway without a crossing treatment (assumes 0% compliance). If the actual total pedestrian delay has been measured at the site, that value can be entered in 4i to replace the calculated value in 4h.		4h	1.0
		4i	
Step 5: Select treatment based up on total pedestrian delay and expected motorist compliance.			
Expected motorist compliance at pedestrian crossings in region: enter HIGH for High Compliance or LOW for Low Compliance		5a	HIGH
Treatment Category:		CROSSWALK

This worksheet provides general recommendations on pedestrian crossing treatments to consider at unsignalized intersections; in all cases, engineering judgment should be used in selecting a specific treatment for installation. This worksheet does not apply to school crossings. In addition to the results provided by this worksheet, users should consider whether a pedestrian treatment could present an increased safety risk to pedestrians, such as where there is poor sight distance, complex geometrics, or nearby traffic signals.

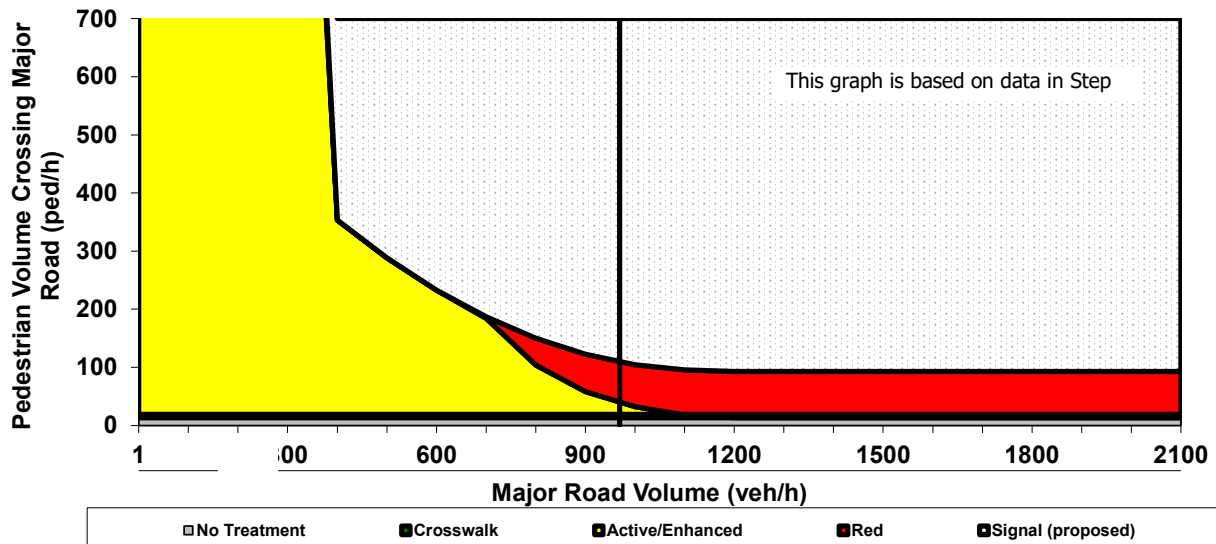
4i	
Step 5: Select treatment based up on total pedestrian delay and expected motorist compliance.			
Expected motorist compliance at pedestrian crossings in region: enter HIGH for High Compliance or LOW for Low Compliance		5a	HIGH
Treatment Category:		ACTIVE OR ENHANCED

This worksheet provides general recommendations on pedestrian crossing treatments to consider at unsignalized intersections; in all cases, engineering judgment should be used in selecting a specific treatment for installation. This worksheet does not apply to school crossings. In addition to the results provided by this worksheet, users should consider whether a pedestrian treatment could present an increased safety risk to pedestrians, such as where there is poor sight distance, complex geometrics, or nearby traffic signals.
